**2024 VISUAL SITE INSPECTION
AES INDIANA PETERSBURG RESTRICTED WASTE TYPE III LANDFILL
SOLID WASTE FACILITY PERMIT NO. FP63-02**

AES INDIANA PETERSBURG GENERATING STATION
6925 NORTH STATE ROAD 57
PETERSBURG, INDIANA 47567

ATLAS PROJECT NO. 170AES0005

DECEMBER 2024

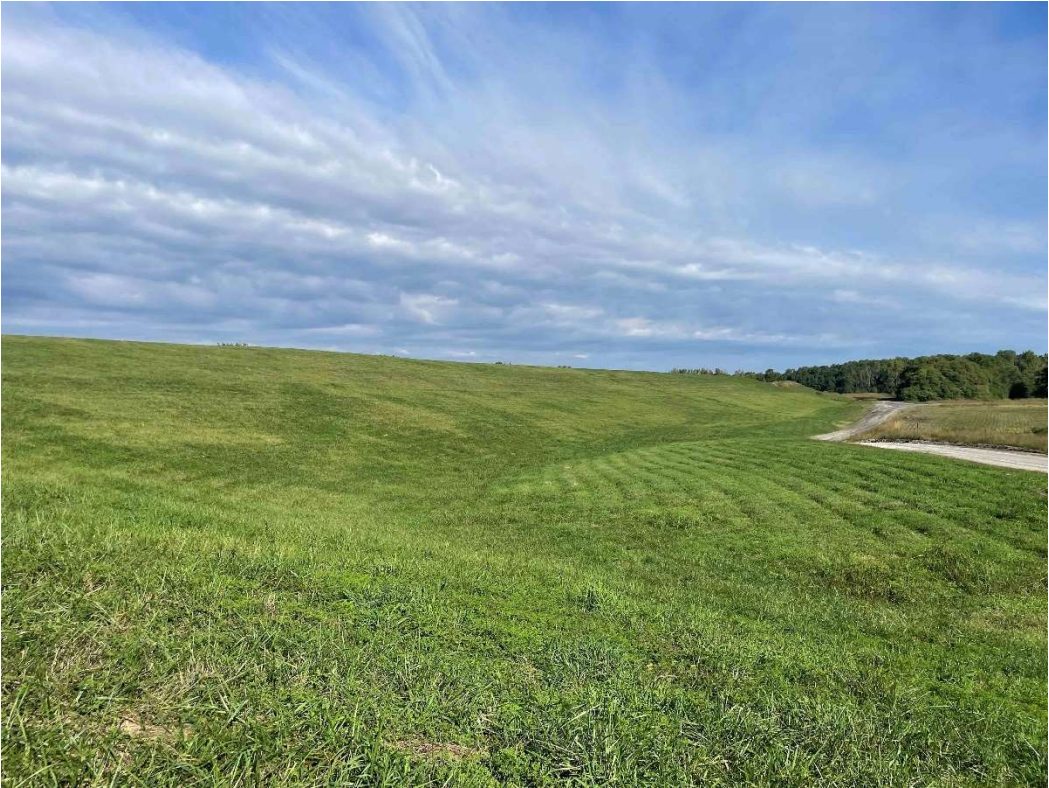
Grid ID R-23	Location ID 1

Date October 1, 2024		
Description: Vegetation well established on the east side of the landfill. Photo looking north. No issues observed.		
Grid ID Q-22	Location ID 2

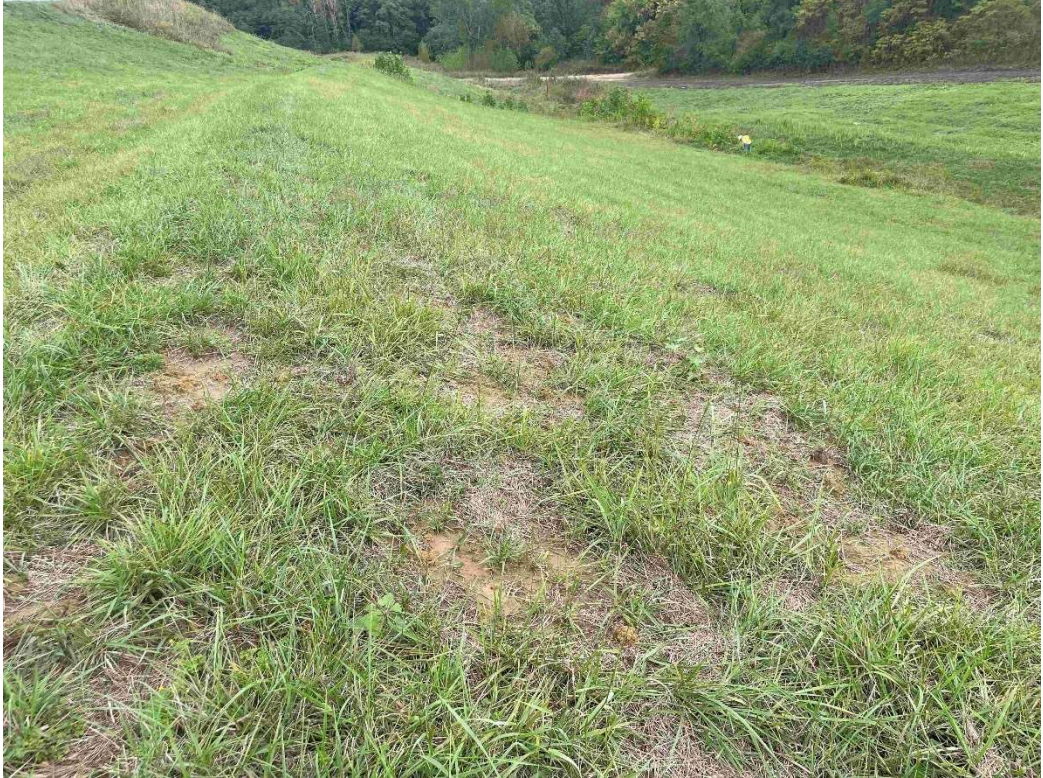
1. Good vegetation exists along much of the south end of the landfill, the top of landfill, and the east slope other than a few bare spots. (Location ID 2 and 7).

Date October 1, 2024		
Description: Sparse vegetation and bare spots on the east slope of the landfill. Photo looking northeast. Recommend reseeding bare areas to prevent erosion.

- Recommendation: Repair the soil cover and overseed these areas to establish a protective grass cover.
2. Overgrown vegetation observed on riprap channel section located on the northeast side of the landfill (Location ID 3, 5, 14, 17, 18, 20, 21, 22, and 25).

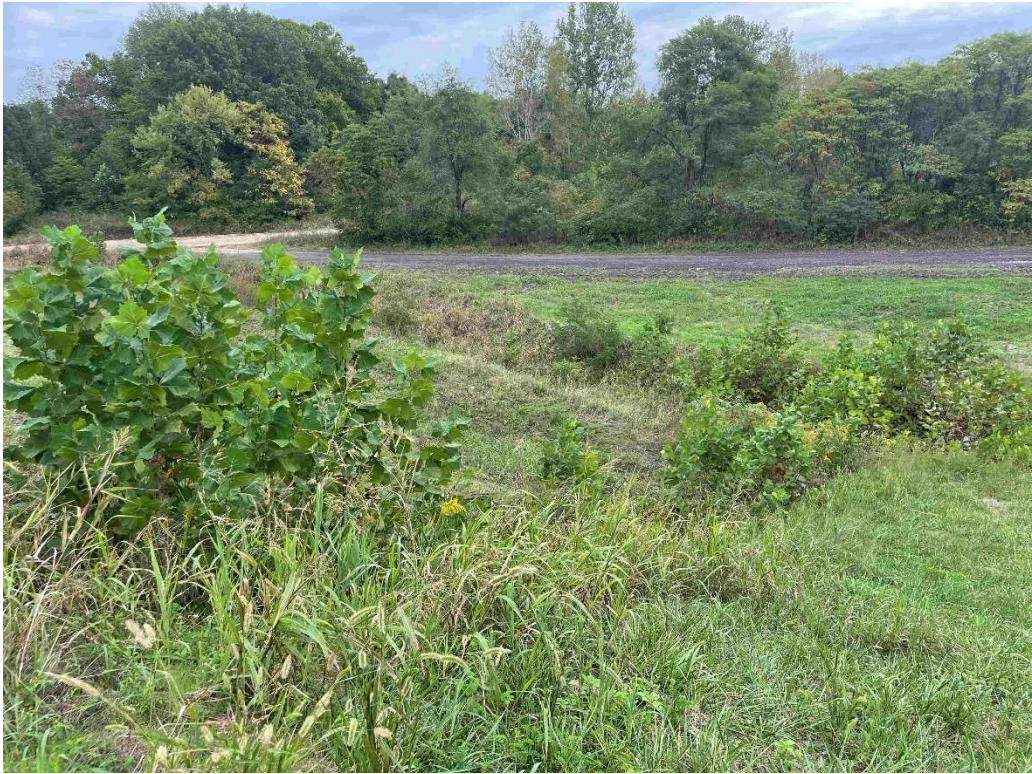
Grid ID Q-17	Location ID 3

Date October 1, 2024		
Description: Overgrown vegetation within interceptor channel on northeast slope of the landfill. Photo looking east. Removal of vegetation within riprap channel is recommended.		
Grid ID P-16	Location ID 4

- Recommendation: Trim and remove the overgrown vegetation to maintain channel flow capacity.
3. Down drainpipes on the east slope of the landfill are covered with debris and vegetation (Location ID 4).

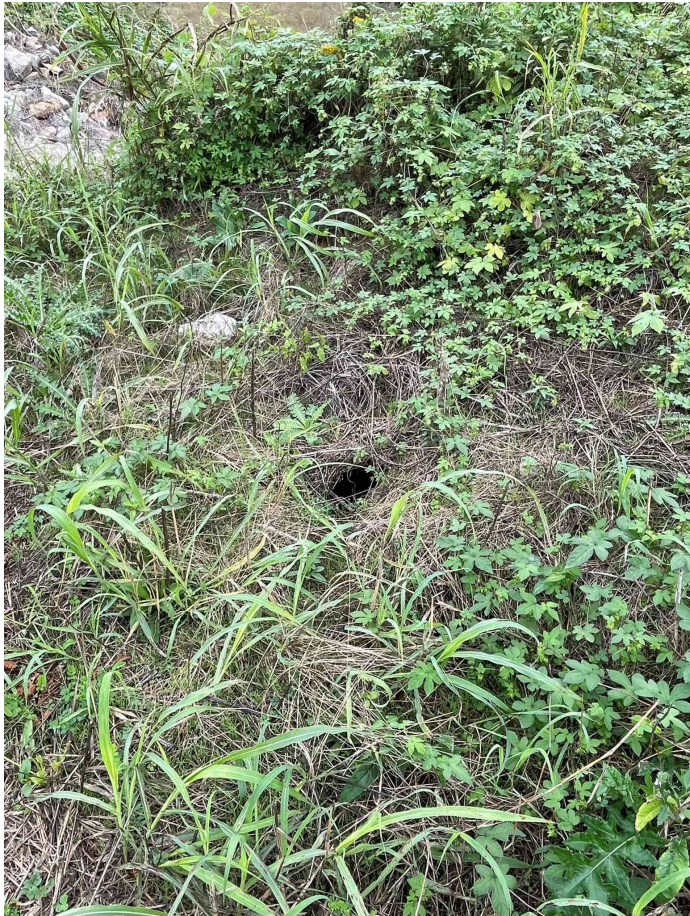
Date October 1, 2024		
Description: Down drainpipes on the east slope of the landfill are covered with debris and vegetation. Recommend removal of vegetation from pipe entrance.

- Recommendation: Trim and remove the overgrown vegetation to maintain channel flow capacity.
4. Animal borrows were observed on the north side of the landfill (Photo ID 14).

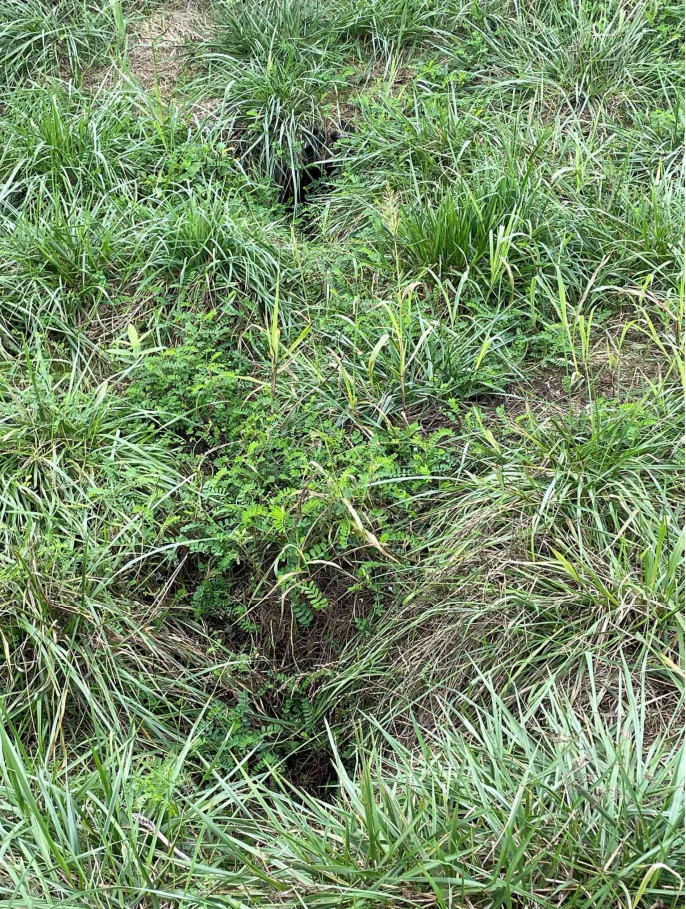
Grid ID Q-15	Location ID 5	 
Date October 1, 2024		
Description: Overgrown vegetation at down drain channel on the northeast slope of landfill. Photo looking south. Recommend removal of vegetation.		
Grid ID Q-15	Location ID 6

Date October 1, 2024		
Description: Down drainpipes on the northeast slope of the landfill are covered with vegetation. Recommend removal of vegetation from pipe entrance.

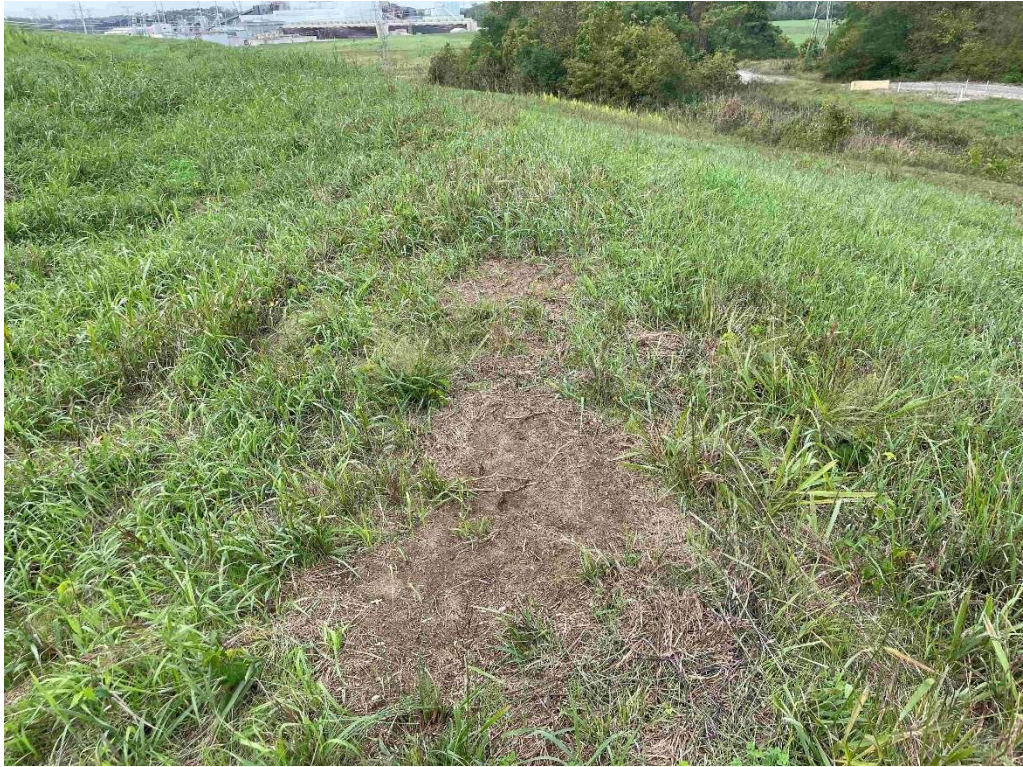
Grid ID Q-15	Location ID 7

Date October 1, 2024		
Description: Sparse vegetation and bare spots on the east slope of the landfill. Photo looking northeast. Recommend reseeding bare areas to prevent erosion.		
Grid ID Q-14	Location ID 8

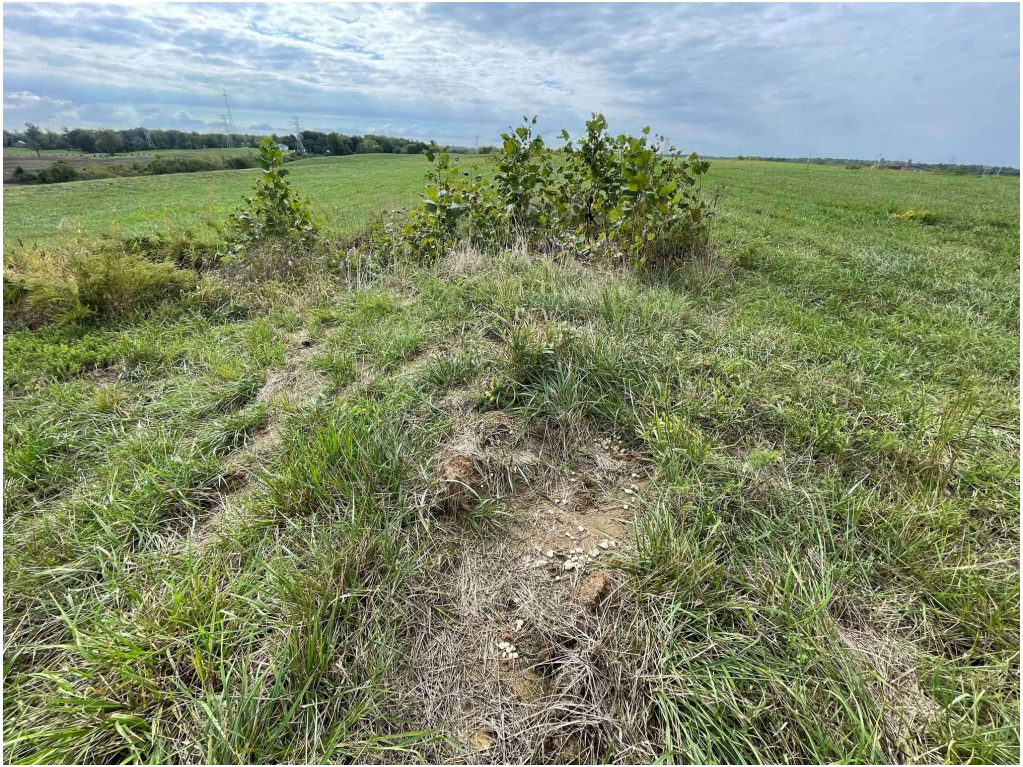
Date October 1, 2024		
Description: Sparse vegetation, overgrown vegetation and bare spots on the northeast slope of the landfill. Photo looking northeast. Recommend reseeding bare areas to prevent erosion and removal of overgrown vegetation.

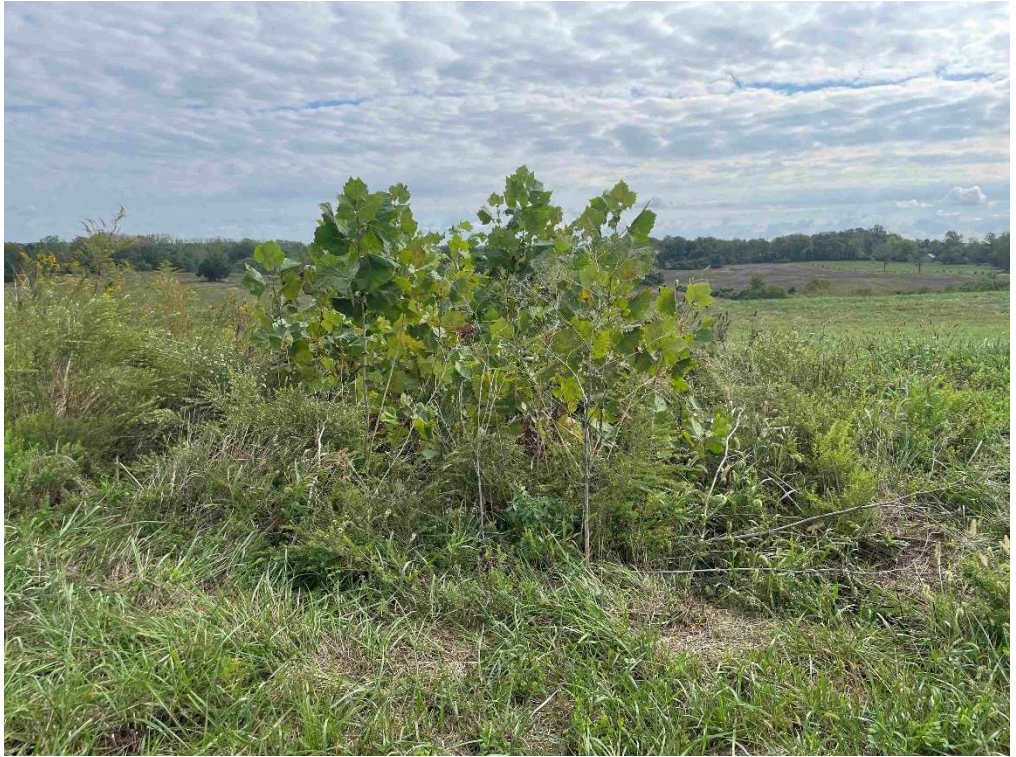
Grid ID P-14	Location ID 9

Date October 1, 2024		
Description: Overgrown vegetation within downdrain channel on northeast slope of the landfill. Photo looking northeast. Recommend removal of vegetation within riprap channel.		
Grid ID P-13	Location ID 10

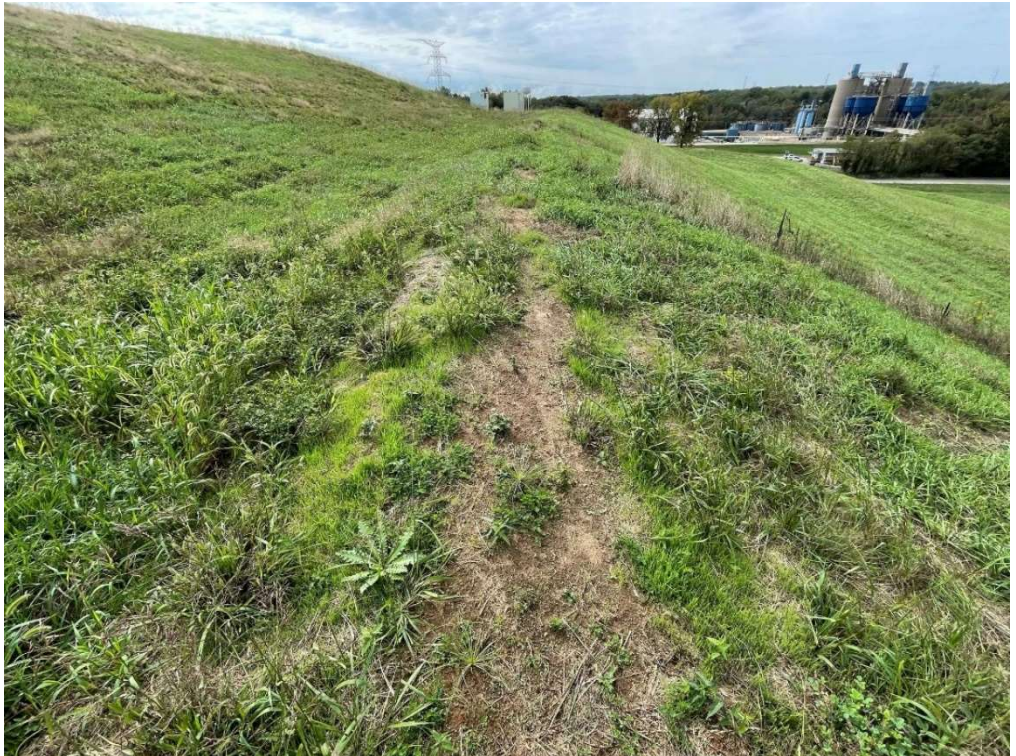
Date October 1, 2024		
Description: Bare spots on the northwest slope of the landfill. Photo looking south. Recommend reseeding bare areas to prevent erosion.

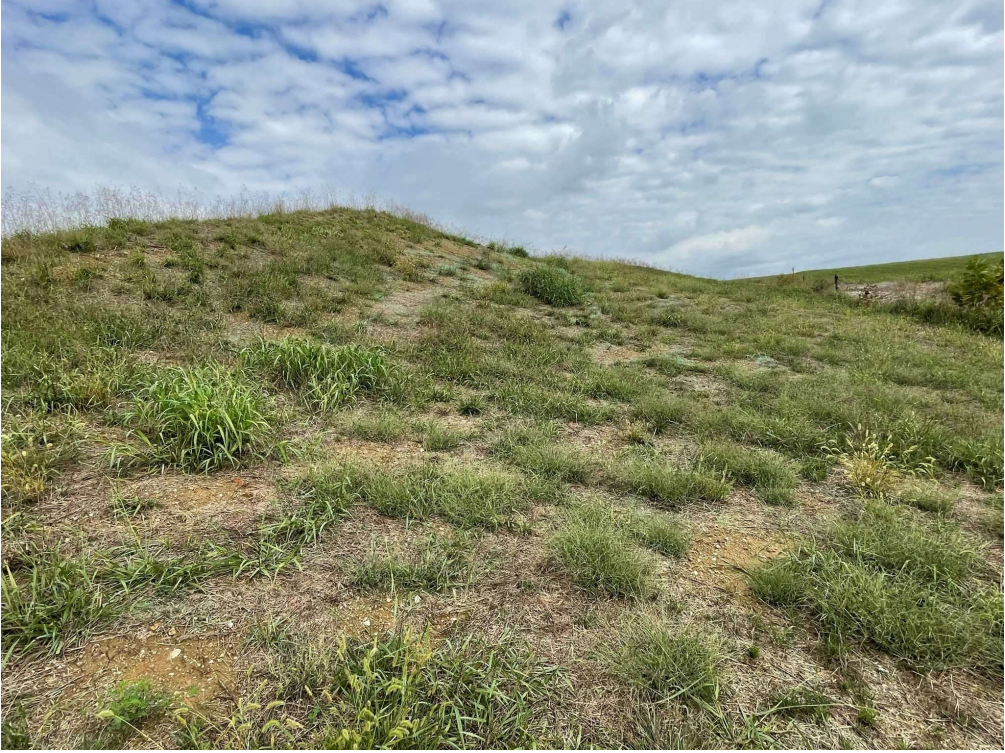
Grid ID O-12	Location ID 11

Date October 1, 2024		
Description: Erosion occurring along north slope. Photo looking south. Recommend re-seed bare spots to prevent erosion and maintain proper grass cover.		
Grid ID N-13	Location ID 12

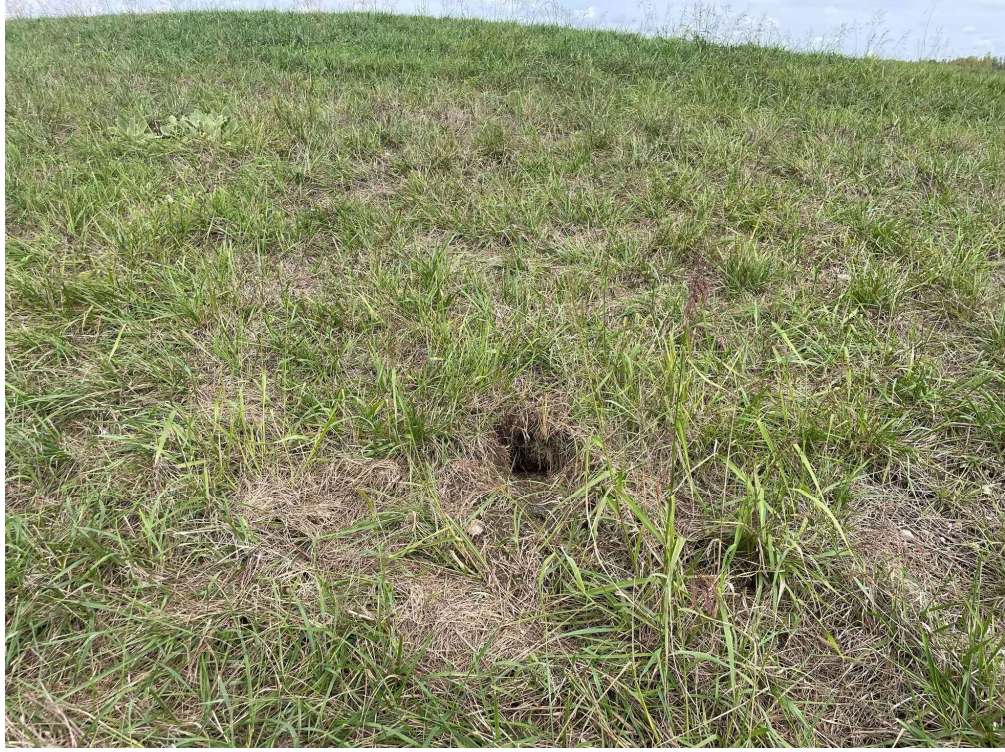
3. Animal burrow observed on the north side slope of the landfill (Location ID 12).
 - Recommendation: Fill in and repair the soil cover and overseed the area to establish a protective grass cover.
4. Overgrown vegetation observed on riprap channel section located on the northeast side of the landfill (Location ID 8, 24, and 25).
 - Recommendation: Trim and remove the overgrown vegetation to maintain channel flow capacity.
5. Down drainpipes on the northwest slope of the landfill are covered with debris and vegetation.
 - Recommendation: Trim and remove the overgrown vegetation and debris to maintain channel flow capacity.

Date October 1, 2024		
Description: Animal burrow on the northwest side slope of the landfill. Photo looking east. Recommend repair and reseeding bare areas to prevent erosion.

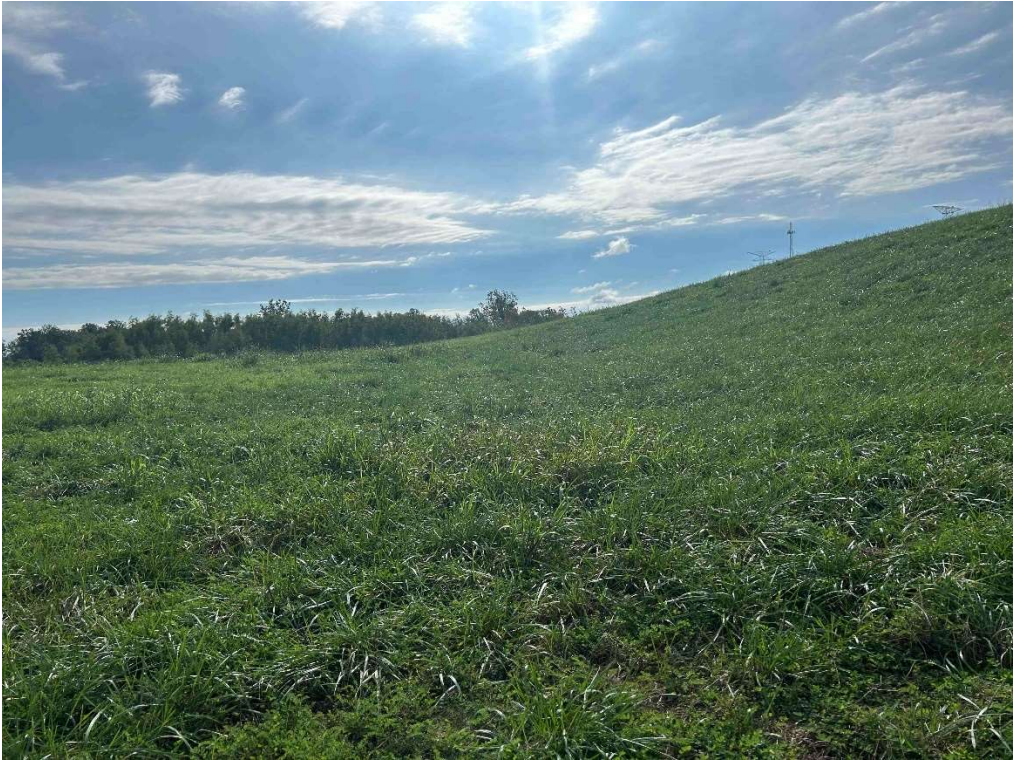
Grid ID N-13	Location ID 13

Date October 1, 2024		
Description: Vegetation well established on top west slope of the landfill. No issues observed. Photo looking southeast.		
Grid ID O-17	Location ID 14

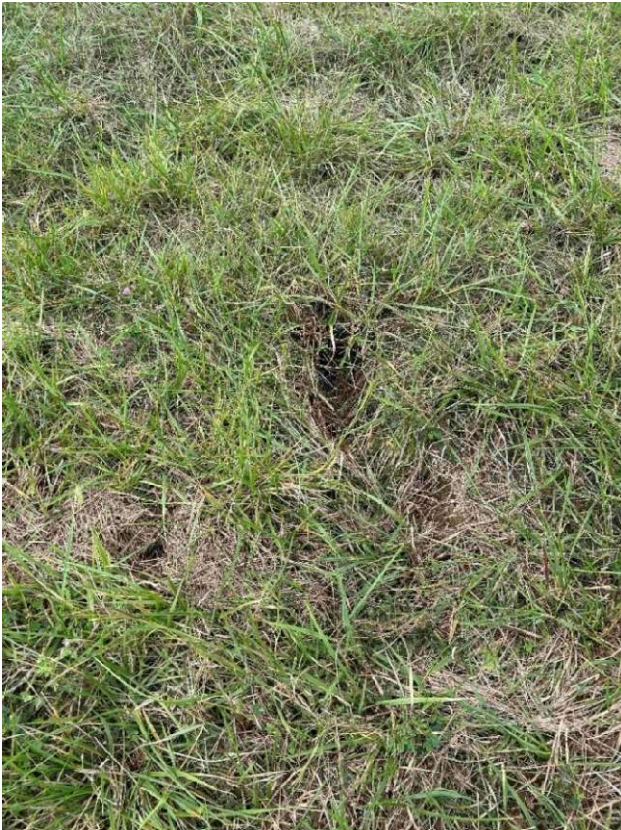
Date October 1, 2024		
Description: Animal burrow on the top cover of the landfill. Photo looking south. Recommend repair and reseeded bare areas to prevent erosion.

- Recommendation: Repair the soil cover and overseed the area to establish a protective grass cover.

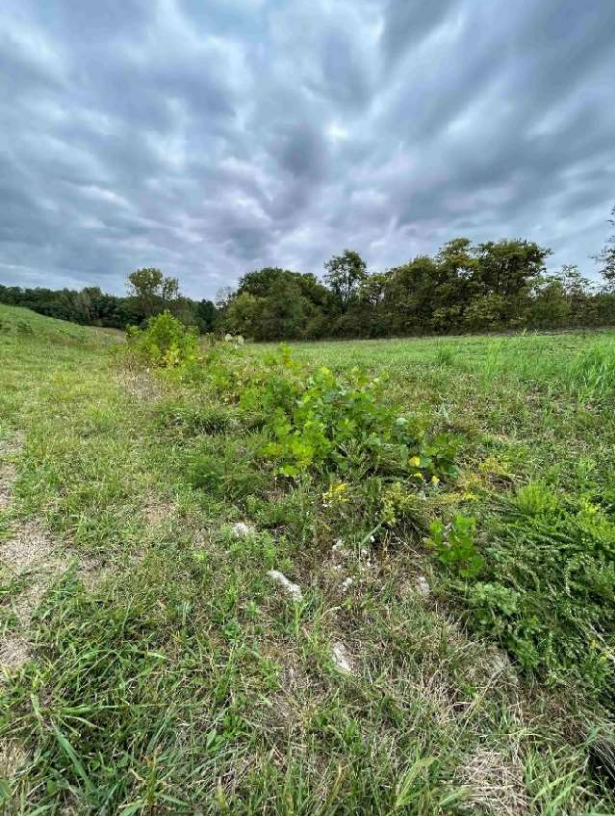
Grid ID M-17	Location ID 15

Date October 1, 2024		
Description: Overgrown vegetation within interceptor channel on top slope of the landfill. Photo looking northeast. Removal of vegetation within riprap channel is recommended.		
Grid ID O-17	Location ID 16

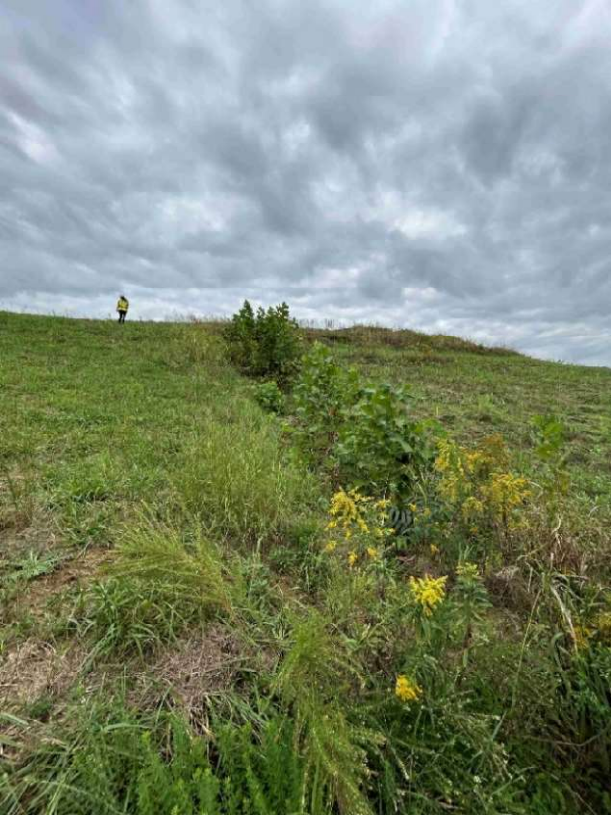
Date October 1, 2024		
Description: Overgrown vegetation within interceptor channel on top slope of the landfill. Photo looking west. Removal of vegetation within riprap channel is recommended.

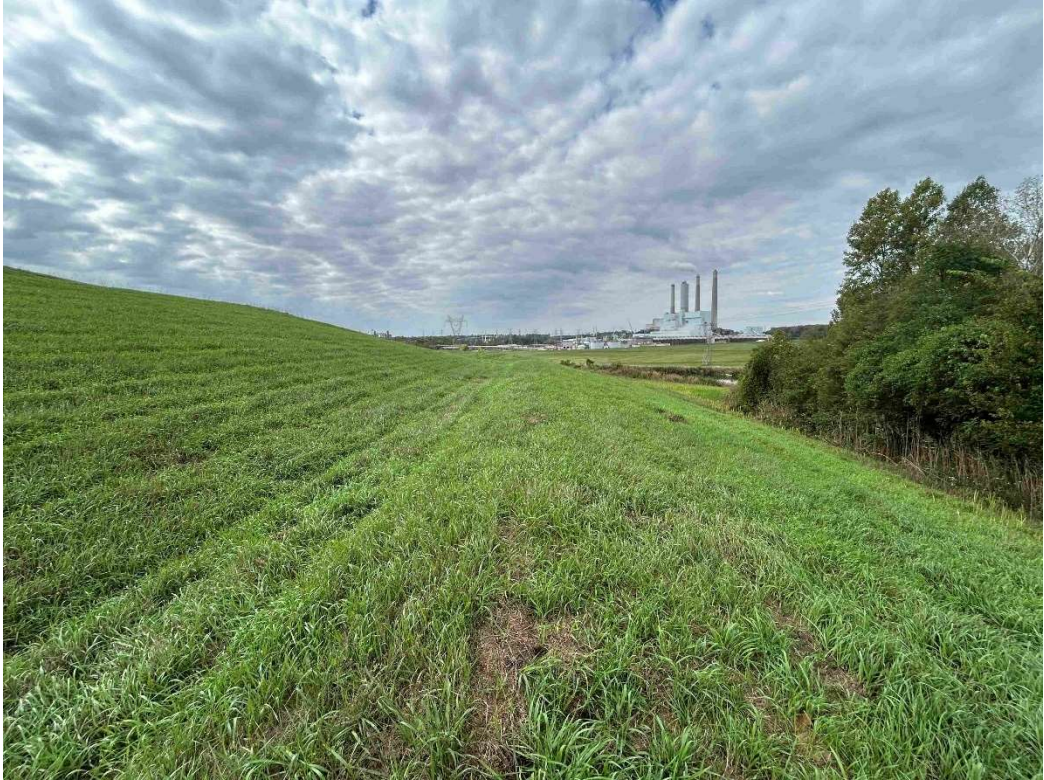
Grid ID N-17	Location ID 17

Date October 1, 2024		
Description: Vegetation well established on top slope of the landfill. Photo looking south. No issues observed.		
Grid ID N-18	Location ID 18

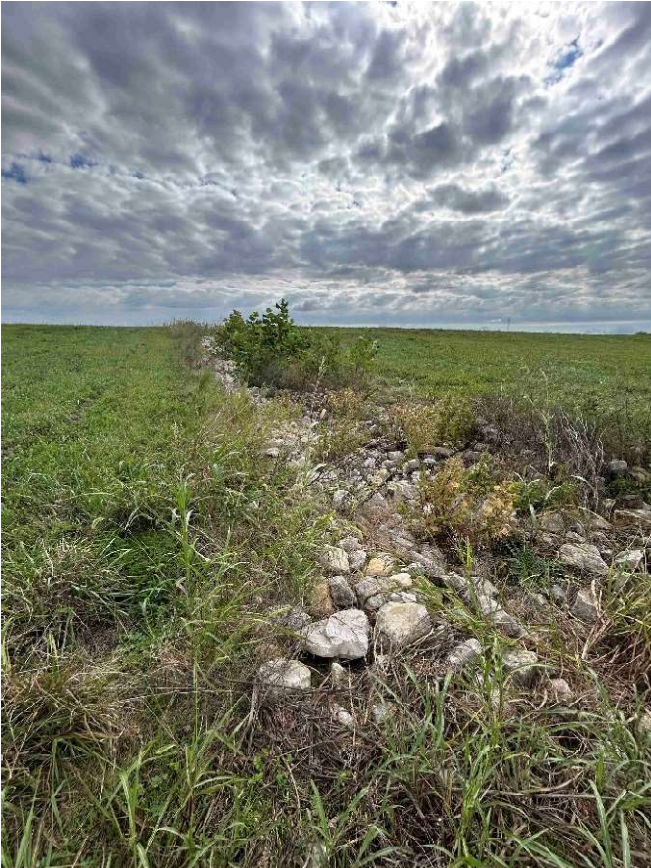
Date October 1, 2024		
Description: Overgrown vegetation within down drain channel on west top slope of the landfill. Photo looking west. Recommend removal of vegetation within riprap channel.

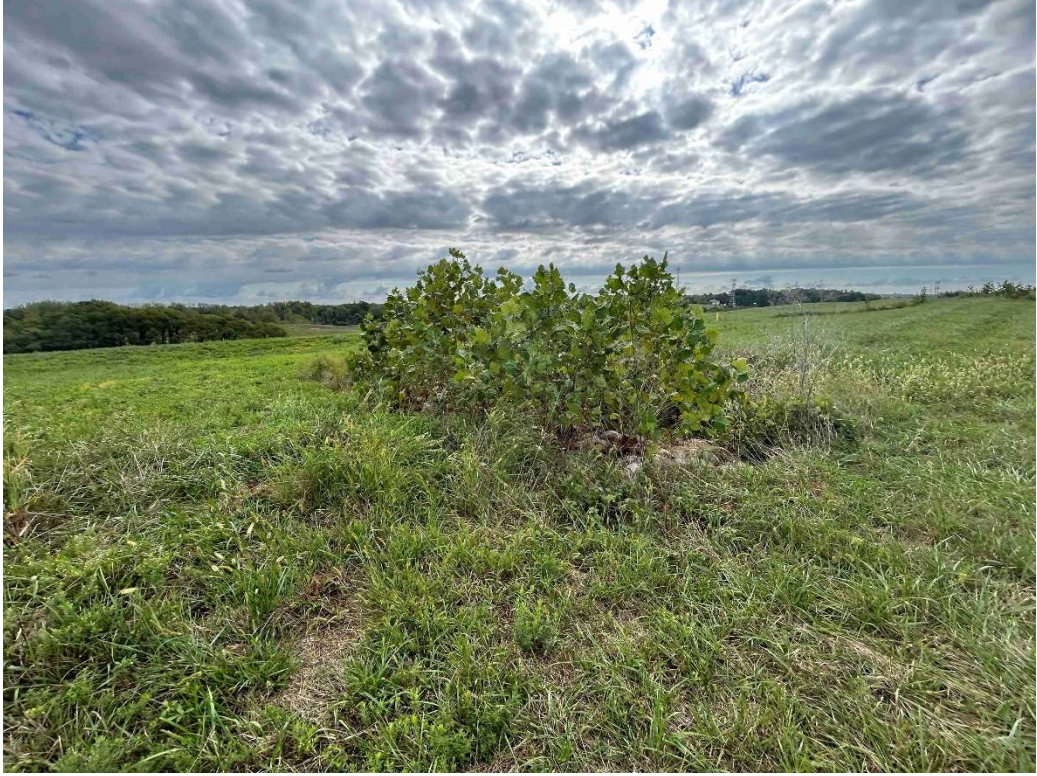
Grid ID O-18	Location ID 19

Date October 1, 2024		
Description: Overgrown vegetation within downrain channel on east top slope of the landfill. Photo looking east. Recommend removal of vegetation within riprap channel.		
Grid ID N-19	Location ID 20

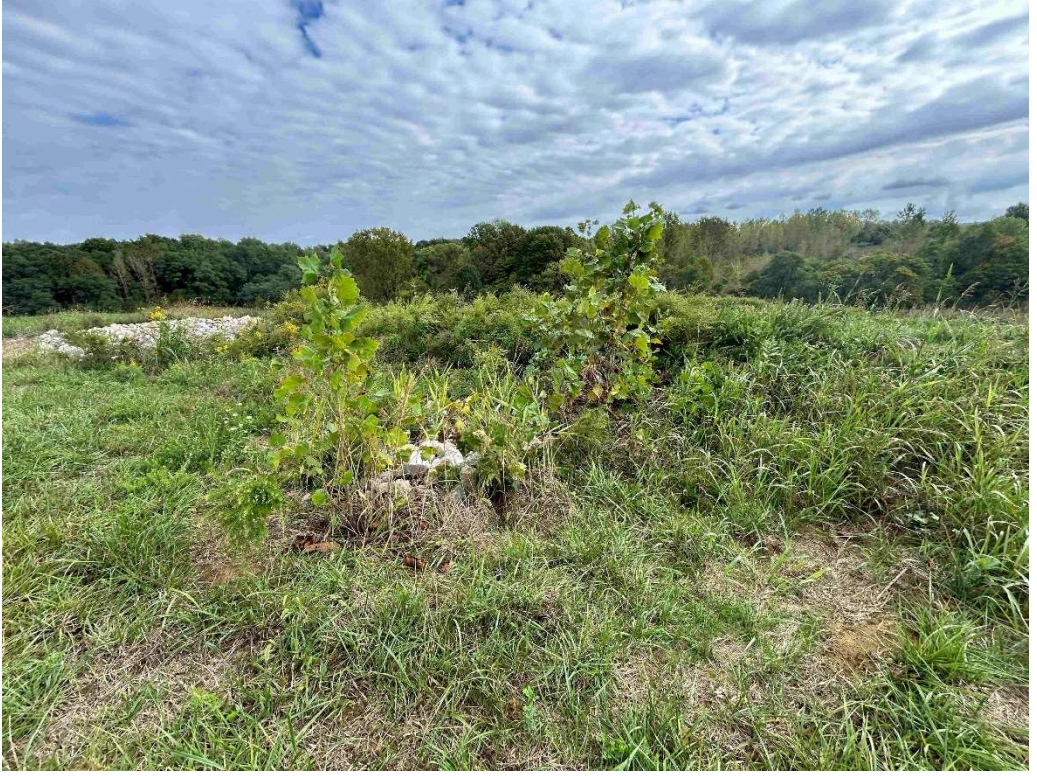
Date October 1, 2024		
Description: Overgrown vegetation within downrain channel on west top slope of the landfill. Photo looking west. Recommend removal of vegetation within riprap channel.

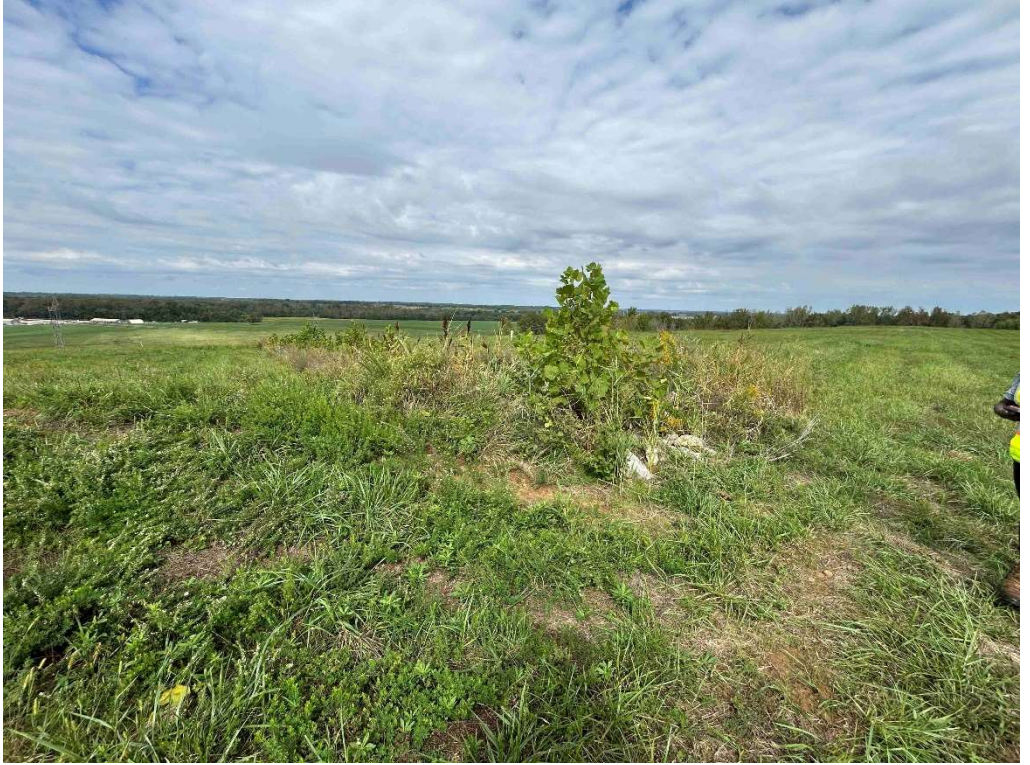
Grid ID O-19	Location ID 21

Date October 1, 2024		
Description: Sparse vegetation, overgrown vegetation and bare spots on the top of the landfill. Photo looking east. Recommend reseeding bare areas to prevent erosion and remove overgrown vegetation.		
Grid ID N-21	Location ID 22

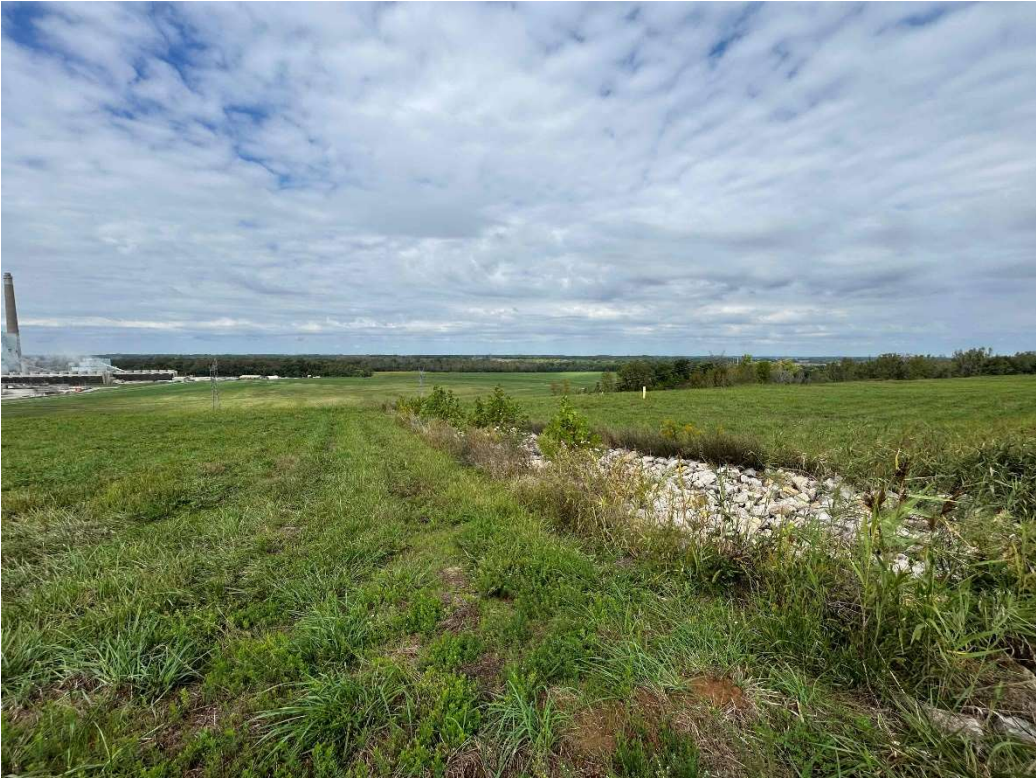
Date October 1, 2024		
Description: Overgrown vegetation within down drain channel on west top slope of the landfill. Photo looking west. Recommend removal of vegetation within riprap channel.

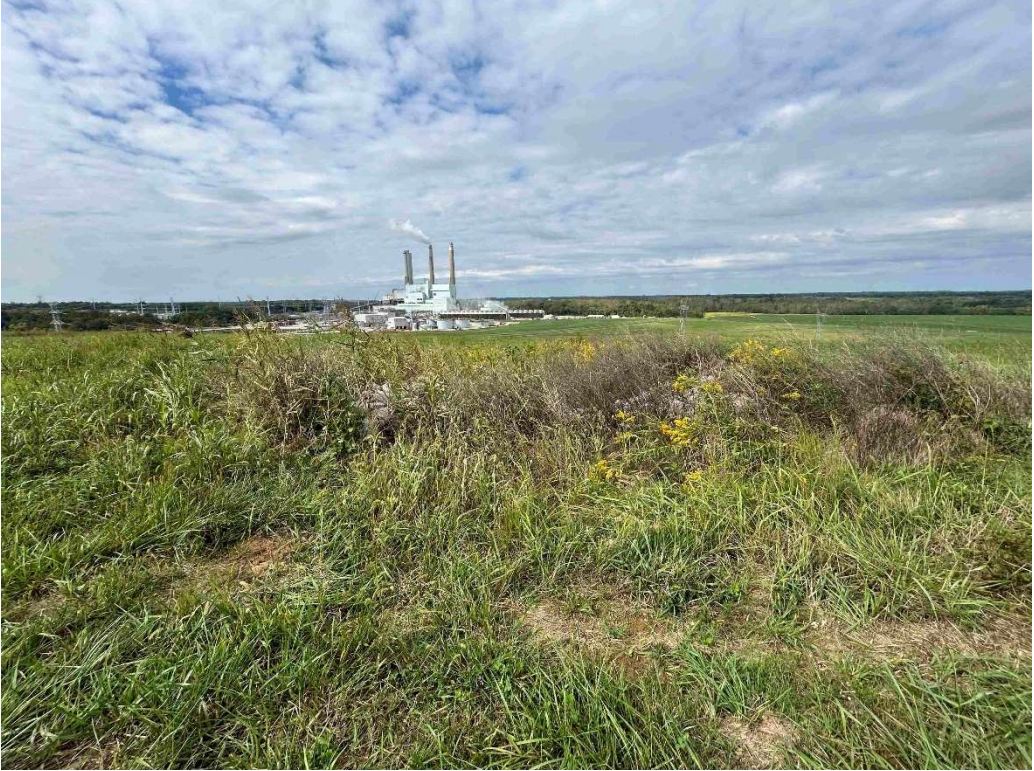
Grid ID N-22	Location ID 23

Date October 1, 2024		
Description: Overgrown vegetation on the west top slope of the landfill. Photo looking west. Recommend removal of vegetation within riprap channel.		
Grid ID M-22	Location ID 24

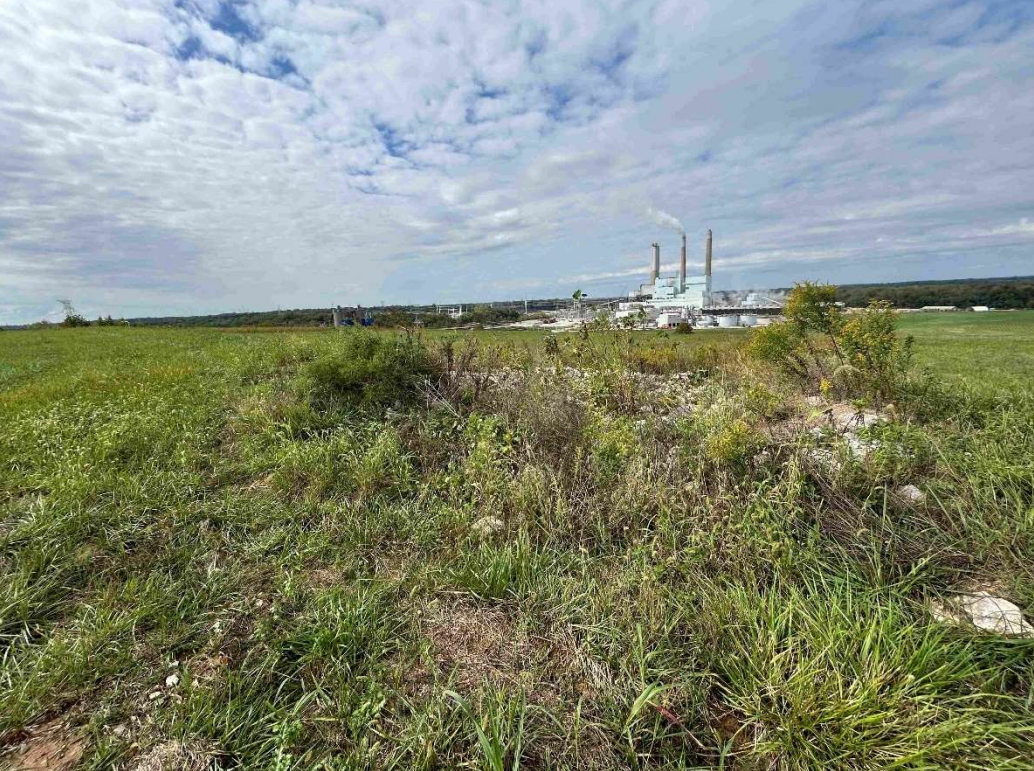
Date October 1, 2024		
Description: Overgrown vegetation within downdrain channel on southwest top slope of the landfill. Photo looking west. Recommend removal of vegetation within riprap channel.

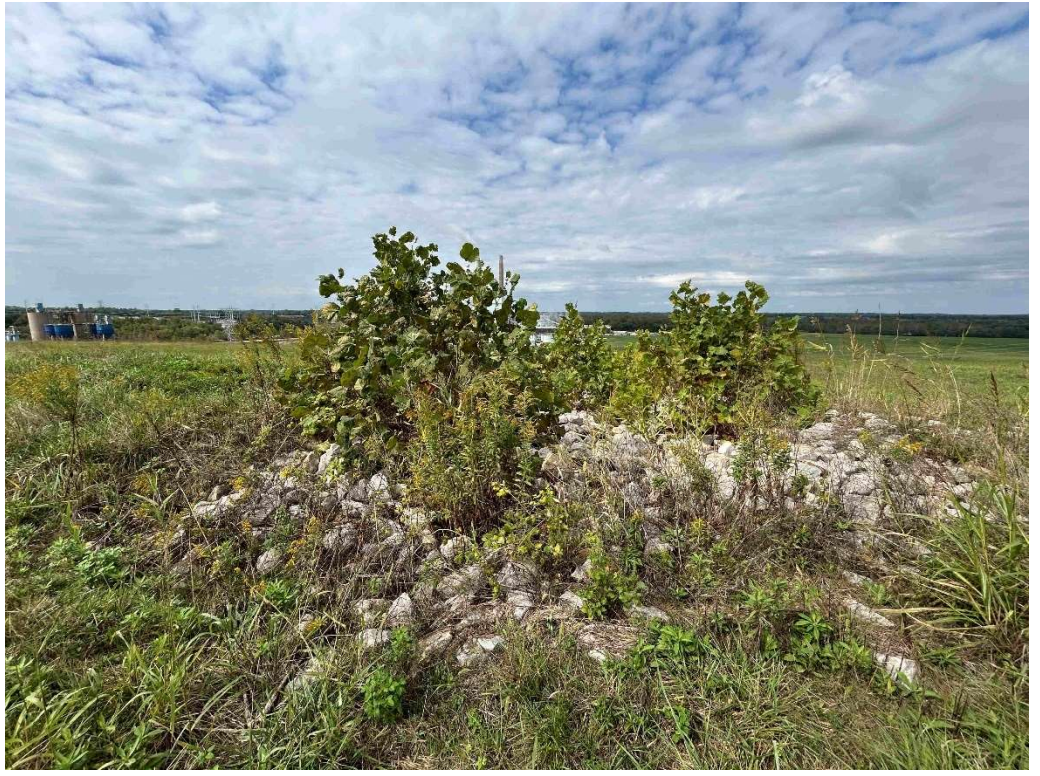
Grid ID M-23	Location ID 25

Date October 1, 2024		
Description: Overgrown vegetation within downdrain channel on southwest slope of the landfill. Photo looking west. Recommend removal of vegetation within riprap channel.		
Grid ID O-18	Location ID 26

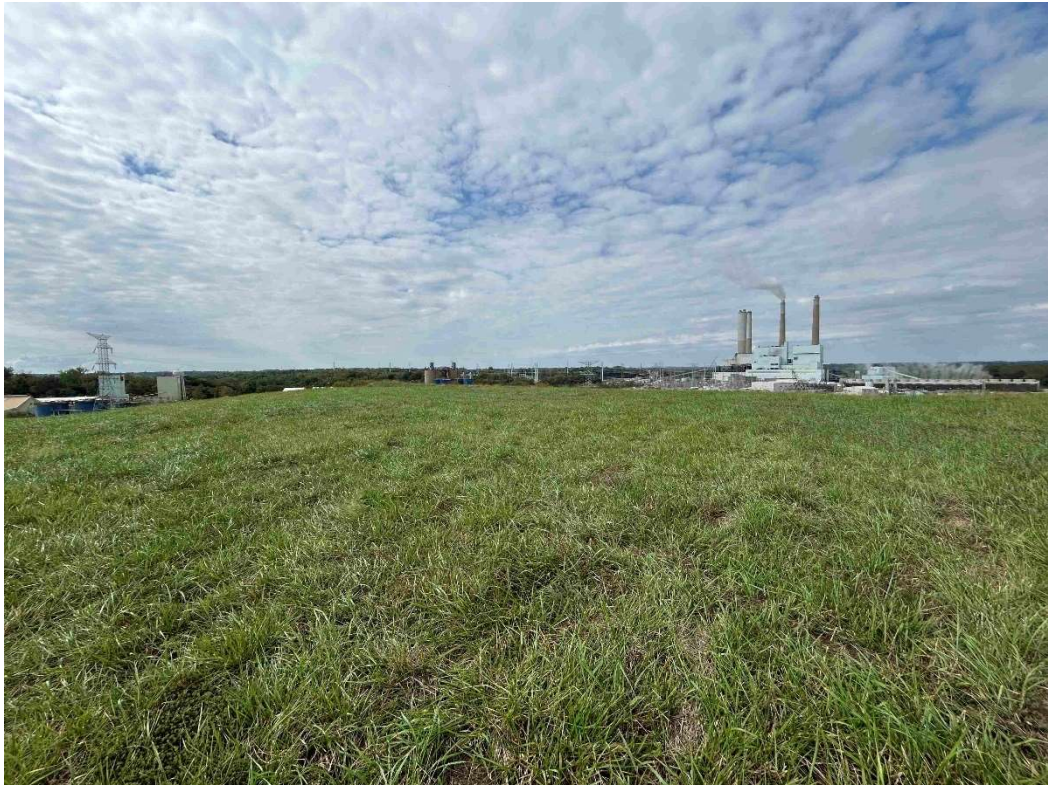
Date October 1, 2024		
Description: Vegetation well established on south slope of the landfill. Photo looking southwest. No issues observed.
