**2019 VISUAL SITE INSPECTION
IPL PETERSBURG RESTRICTED WASTE TYPE III LANDFILL
SOLID WASTE FACILITY PERMIT NO. FP63-02**

IPL PETERSBURG GENERATING STATION
6925 NORTH STATE ROAD 57
PETERSBURG, INDIANA 47567

ATC PROJECT NO. 170LF00600

DECEMBER 11, 2019

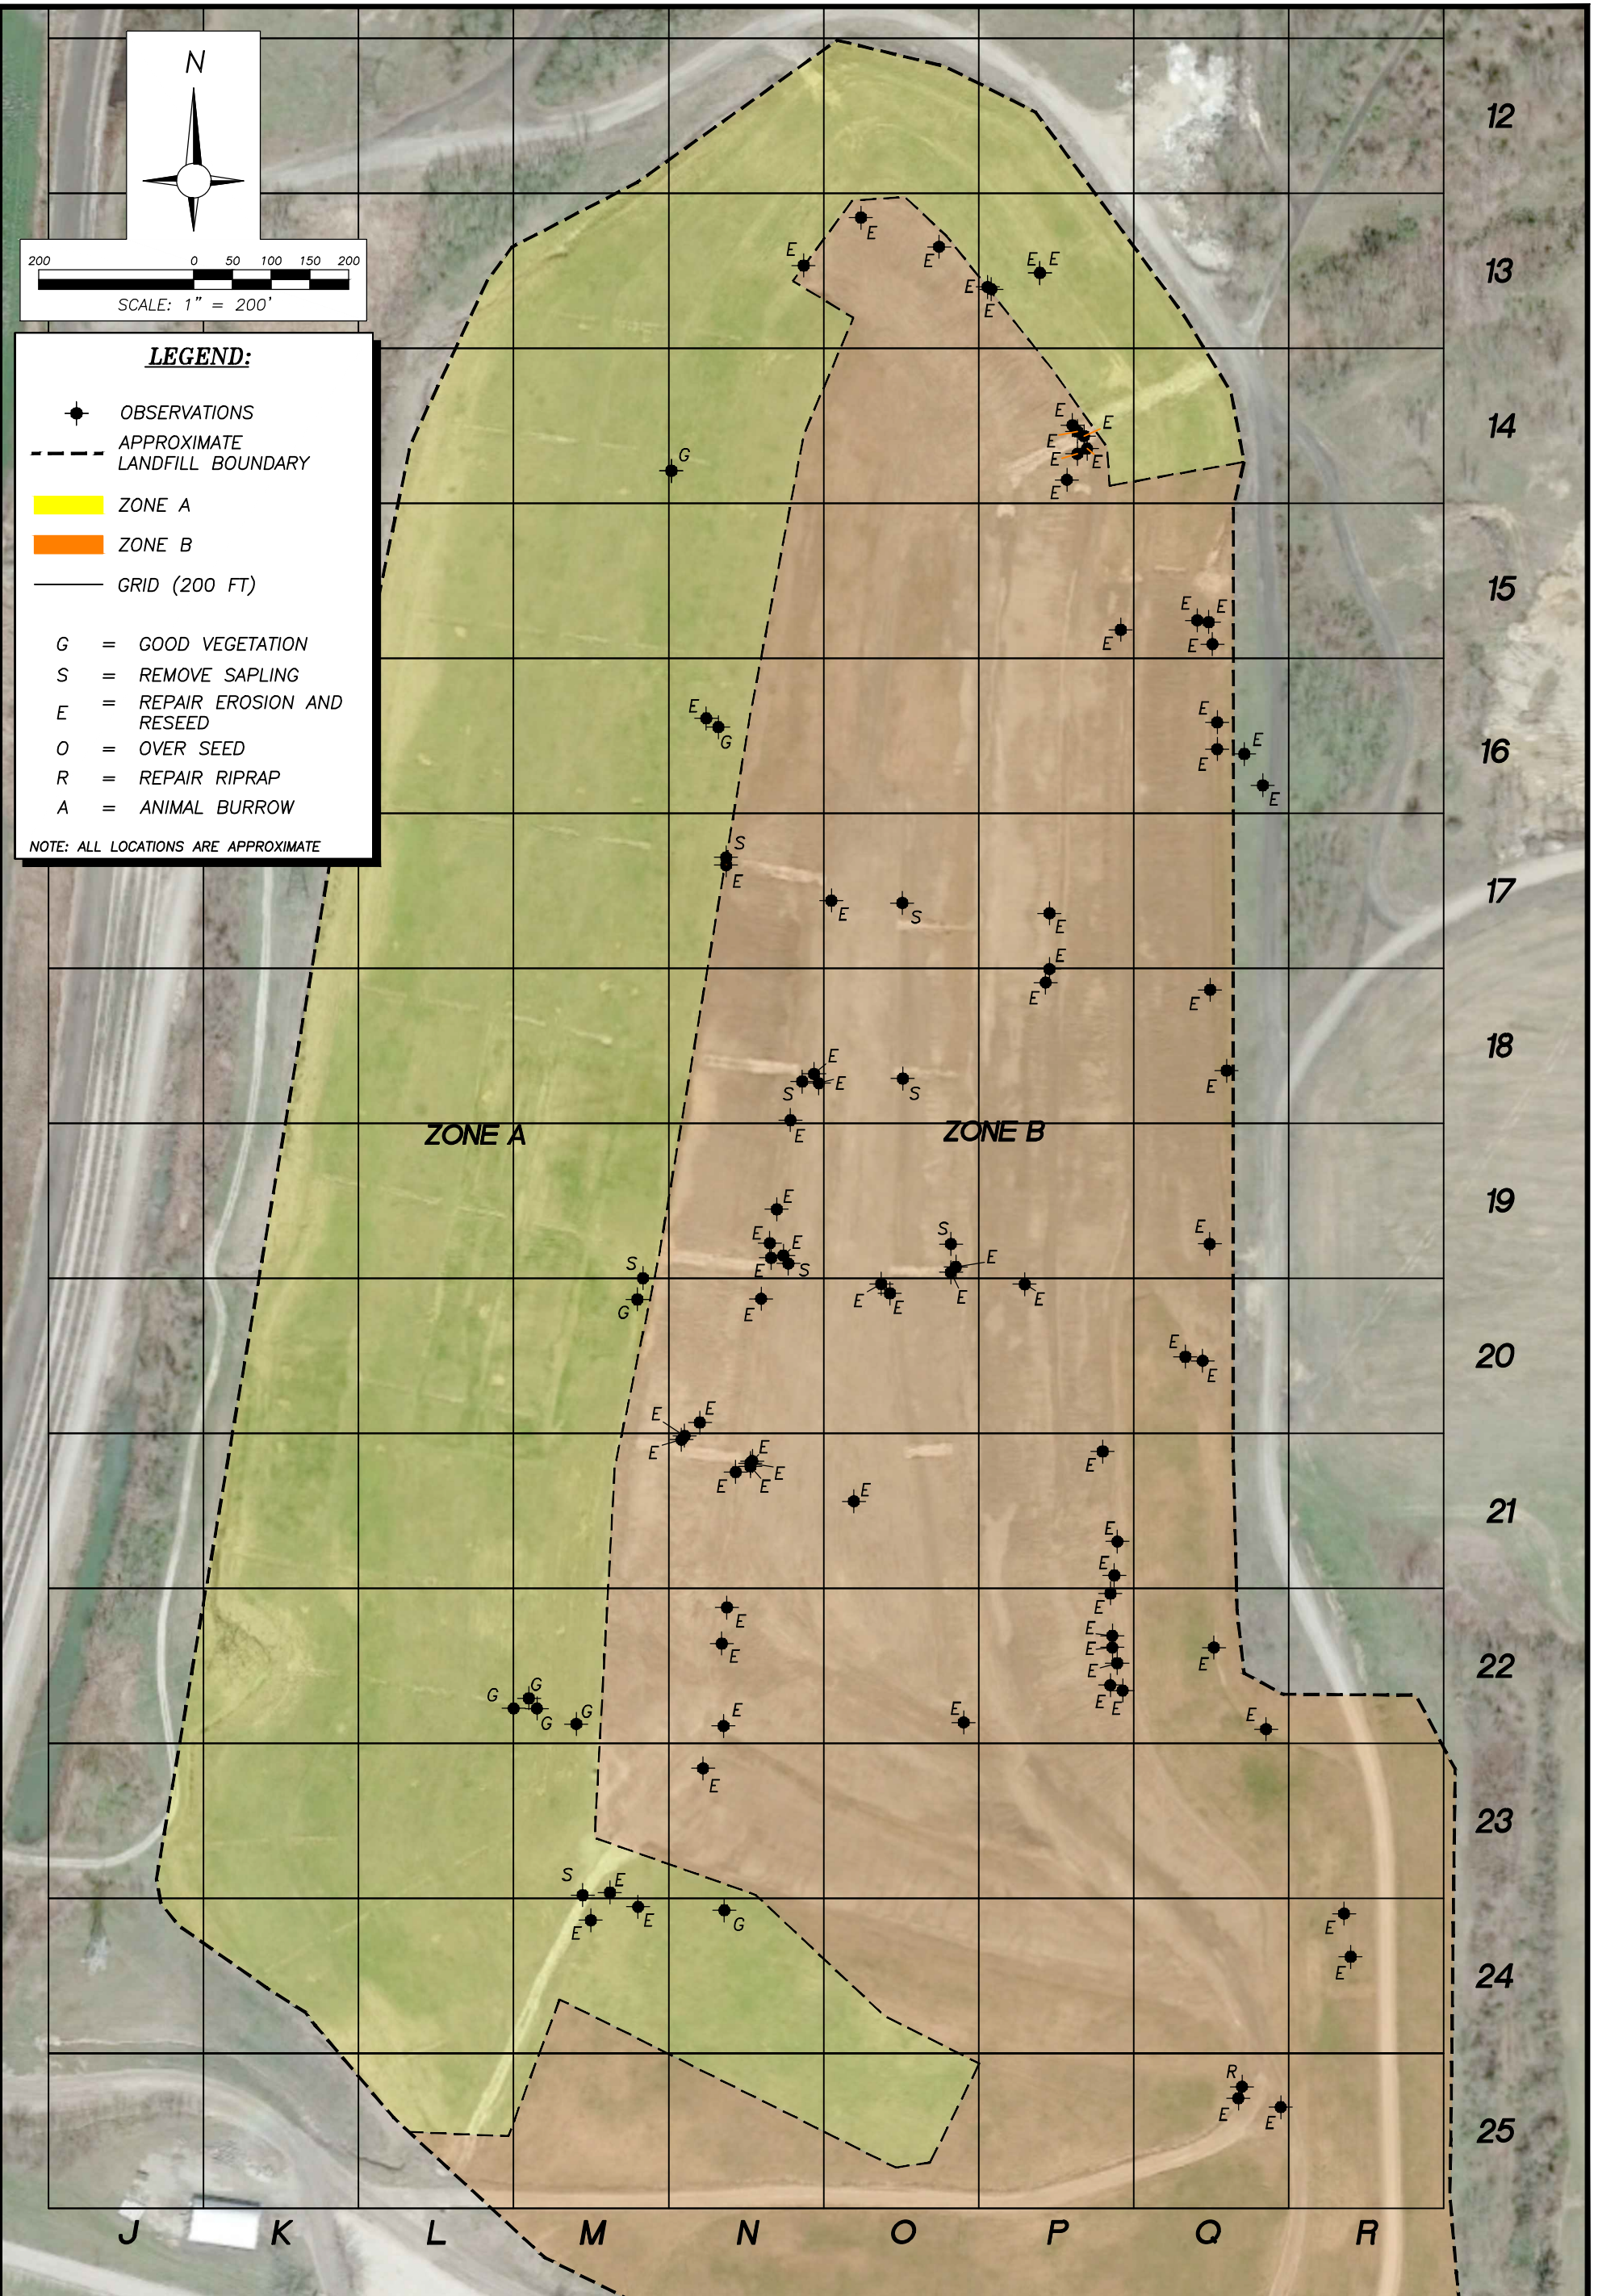
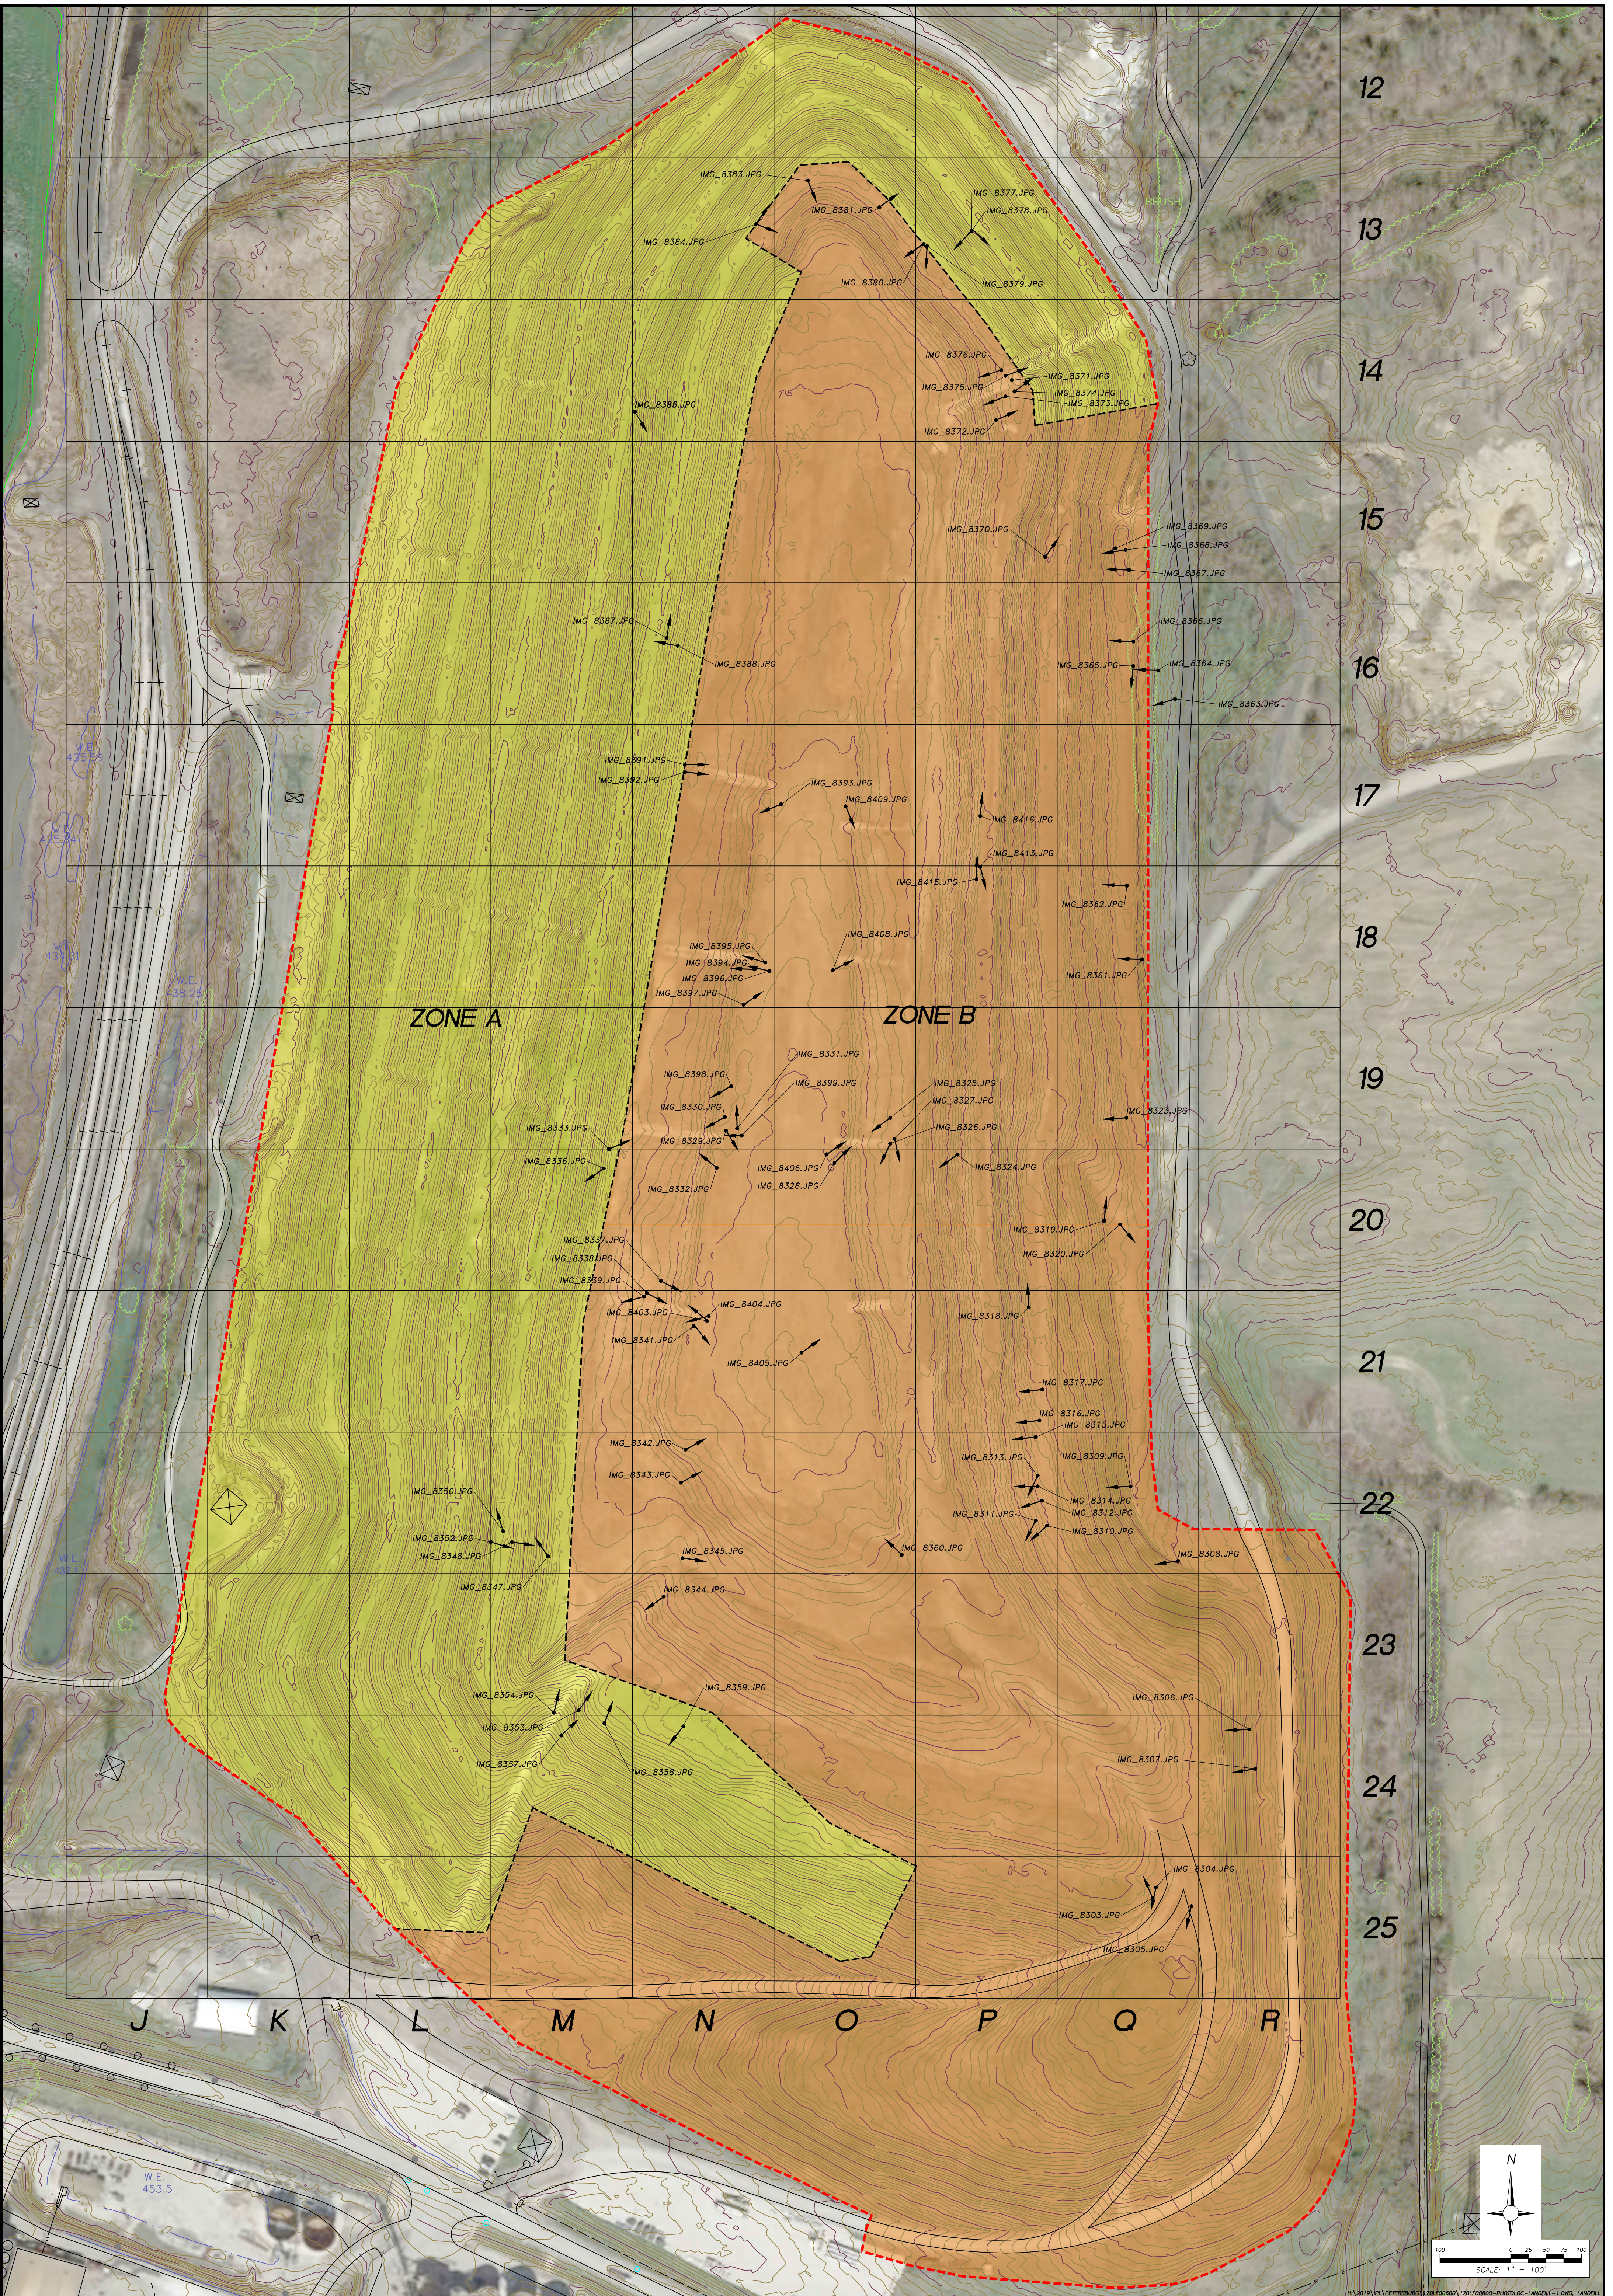
Observed geometry changes during the 2019 Petersburg visual landfill inspection consisted mainly of small grading measures and vegetation improvements. Engineering observations were grouped into two inspection zones shown in Figure 3, 2019 Visual Site Inspection Grid Map.

1. Good vegetation exists along the majority of the west and north slopes of the partial closure area as shown in Figure 3, grid locations L23, L22, K19, M15, and M14.
2. A sapling has grown at the base of one of the riprap down chute channels along the west slope of the landfill, see grid location K19.
 - Recommendation: Remove the sapling to prevent root undermining of the soil cover. Continue an ongoing maintenance program to remove trees and shrubs from the cover system.

3. The northeast corner of the landfill, at the base of a riprap down chute channel, a washout erosion area has formed, see grid location Q13.
 - Recommendation: Install erosion control protection for this area such as erosion control mat to protect the integrity of the soil liner. Overseed the bare soil cover area.
4. At the southwest corner of the landfill, erosion has occurred along the face of the slope, exposing underlying poz-o-tec material, see grid location M23.
 - Recommendation: Repair the soil cover and regrade areas of the slope where erosion has occurred. Install erosion control mat in exposed areas and overseed areas of sparse vegetation once soil cover has been repaired.

4. At the top of landfill erosion rills and gullies were observed at certain locations as shown in grid N23, M23, N22, O22, O21, N20, O20, N19, N18, O18, O17, N16, N15, O15, and O14.

5. Along the eastern and northern side slope of the landfill, erosion rills and gullies were observed at locations as shown in grid P22, Q22, P21, Q20, Q19, Q18, Q17, P16, Q16, P15, Q15, P14, P13, O13 and N13.
 - Recommendation: Repair the soil cover and install erosion control mats in areas affected by erosion rills and erosion cavities. Overseed these areas to establish a protective grass cover.

- Recommendation: Repair the soil cover and install erosion control mats in areas affected by erosion rills and gullies. Overseed these areas to establish a protective grass cover.

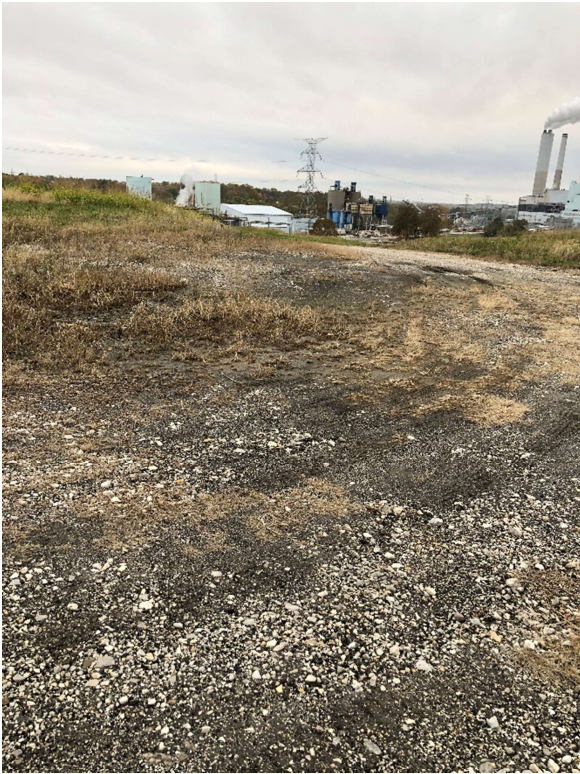
Grid ID Q-25	Photo ID IMG_8305

Date October 29, 2019		
Description: Sparse vegetation, access road turnaround in disrepair with poor grading and drainage on section next to Haul Road.		
Point ID R-24	Photo ID IMG_8306

2. Exposed and bare spot areas were observed on soil cover section next to the haul road, see grid location Q25.
 - Recommendation: Repair the soil cover in exposed bare area and regrade it to improve drainage flow to haul road swale.

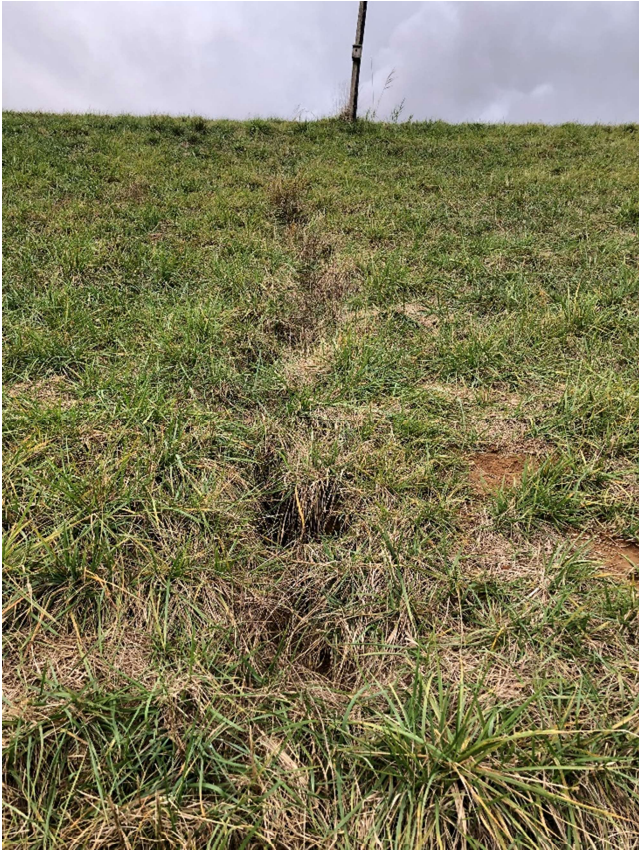
Date October 29, 2019		
Description: Erosion gully formed along eastern section of Zone B, photo looking west.

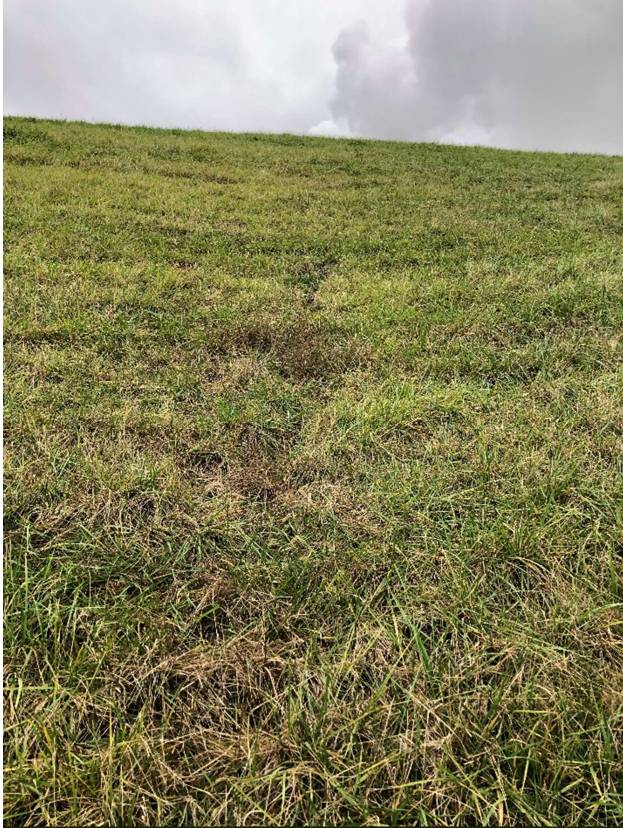
Point ID Q-22	Photo ID IMG_8309

Date October 29, 2019		
Description: Erosion gully formed along eastern section of Zone B, photo looking northwest.		
Point ID P-22	Photo ID IMG_8310

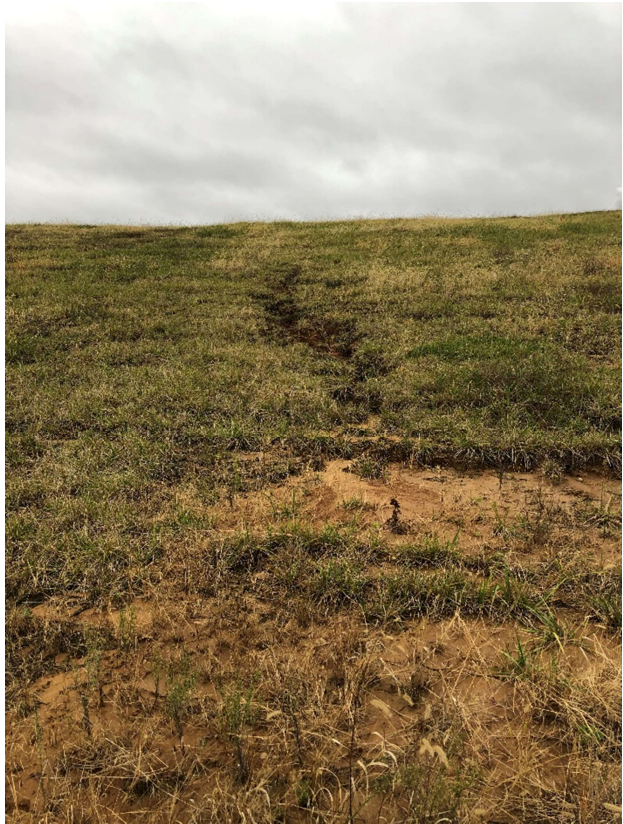
Date October 29, 2019		
Description: Sparse vegetation and erosion gully formed along western section of Zone B, photo looking west.

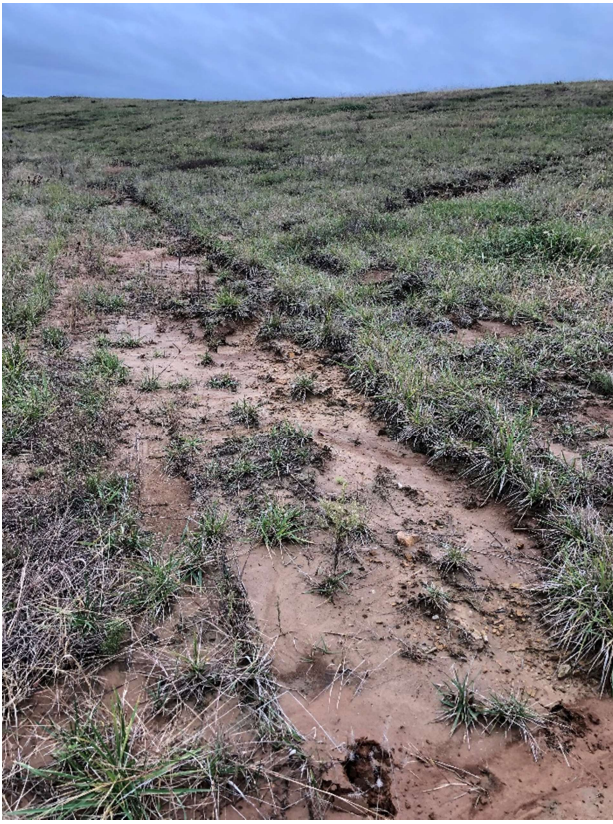
Point ID P-22	Photo ID IMG_8311

Date October 29, 2019		
Description: Sparse vegetation along drainage swale, east slope, Zone B, photo looking south.		
Point ID P-22	Photo ID IMG_8312

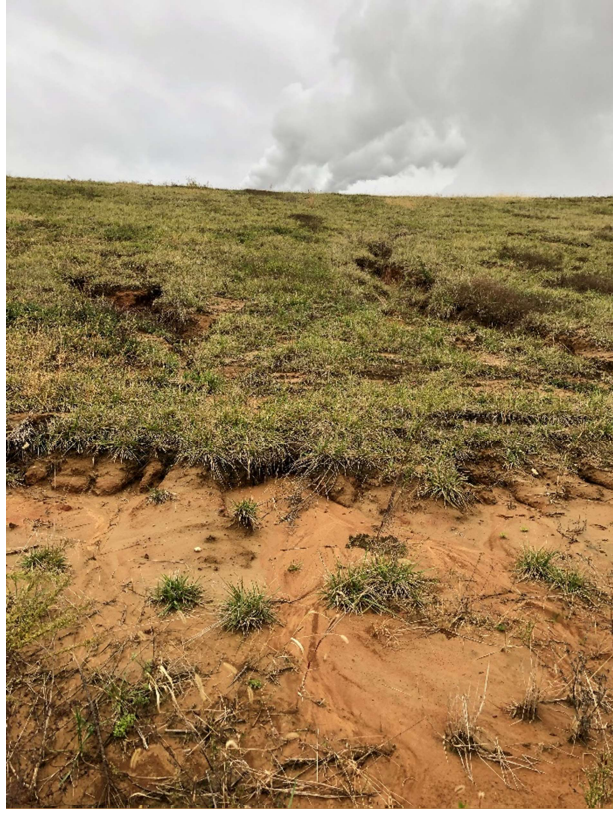
Date October 29, 2019		
Description: Sparse vegetation and erosion gully formed along western section of Zone B, photo looking west.

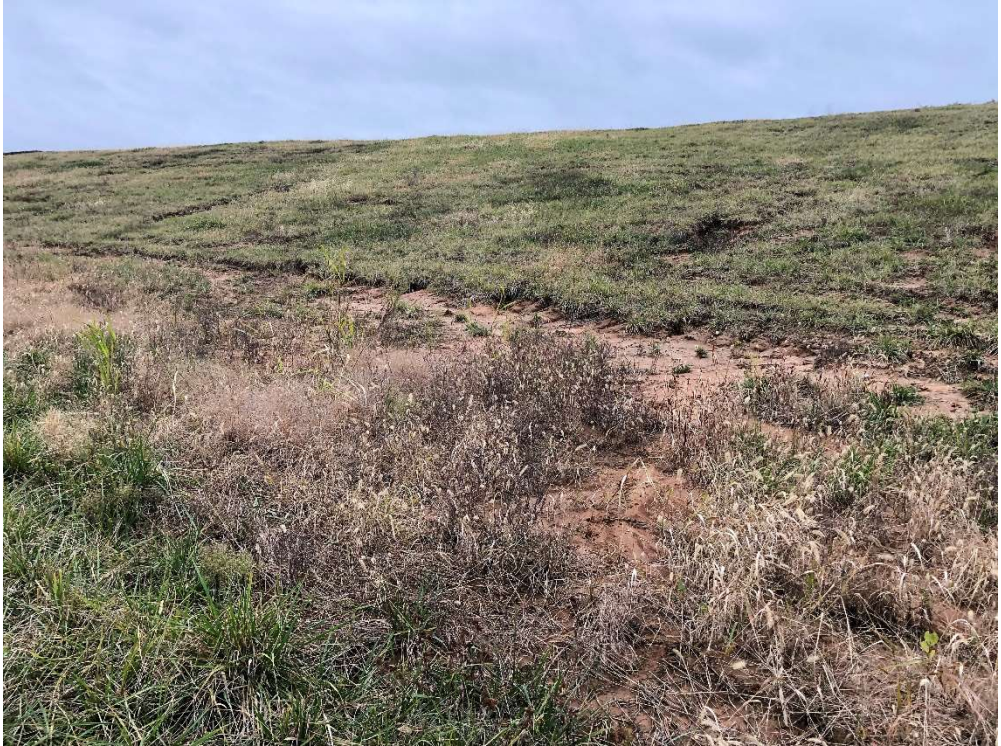
Point ID P-22	Photo ID IMG_8313

Date October 29, 2019		
Description: Sparse vegetation and erosion gully formed along western section of Zone B, photo looking southwest.		
Point ID P-22	Photo ID IMG_8314

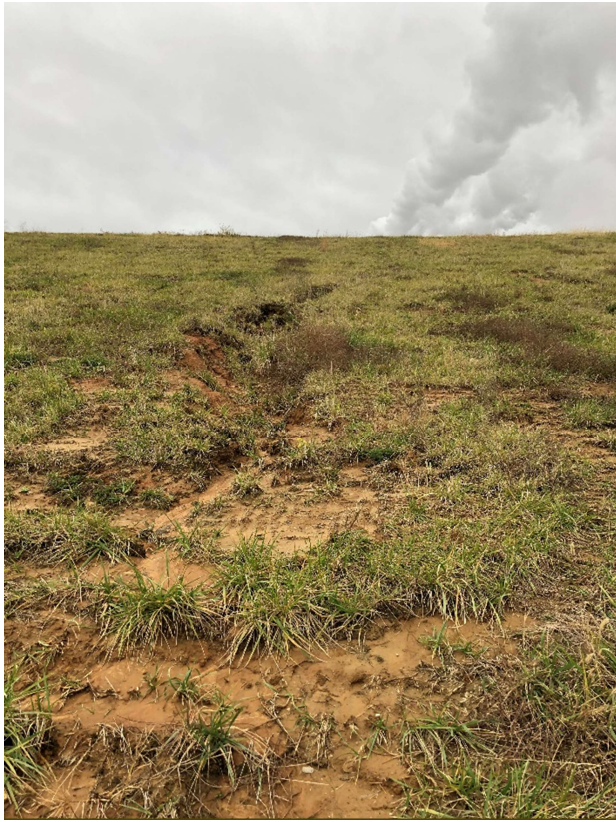
Date October 29, 2019		
Description: Sparse vegetation and erosion gully formed along western section of Zone B, photo looking west.

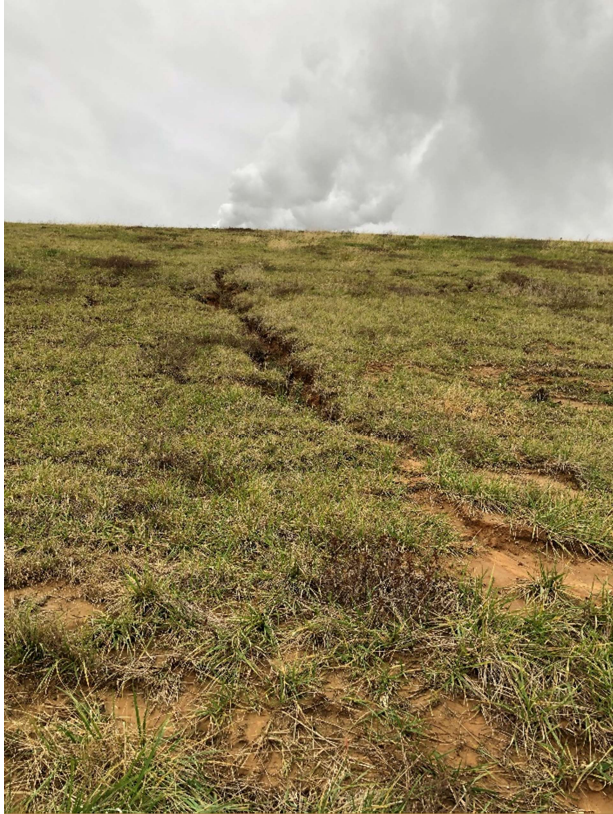
Point ID P-22	Photo ID IMG_8315

Date October 29, 2019		
Description: Sparse vegetation and erosion gully formed along western section of Zone B, photo looking west.		
Point ID P-21	Photo ID IMG_8316

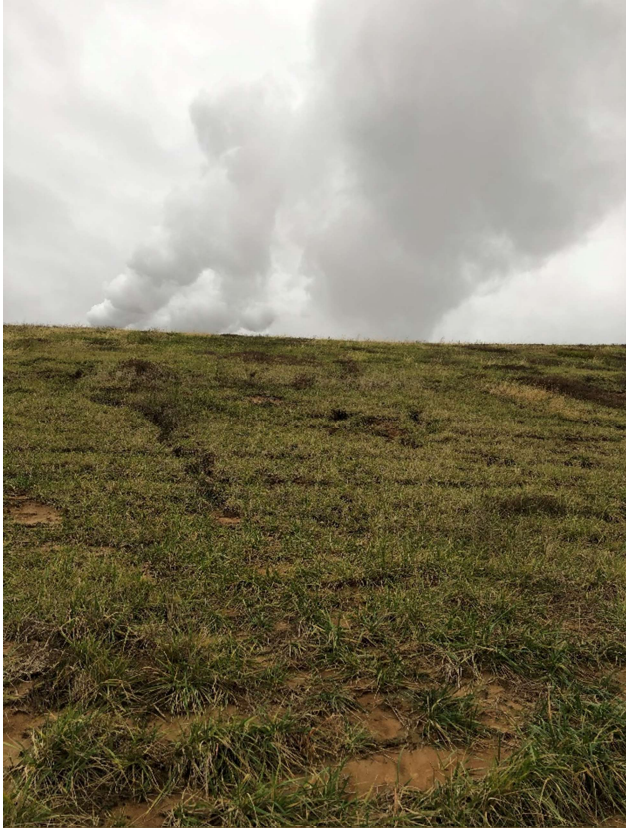
Date October 29, 2019		
Description: Erosion gully formed along eastern section of Zone B, photo looking west.

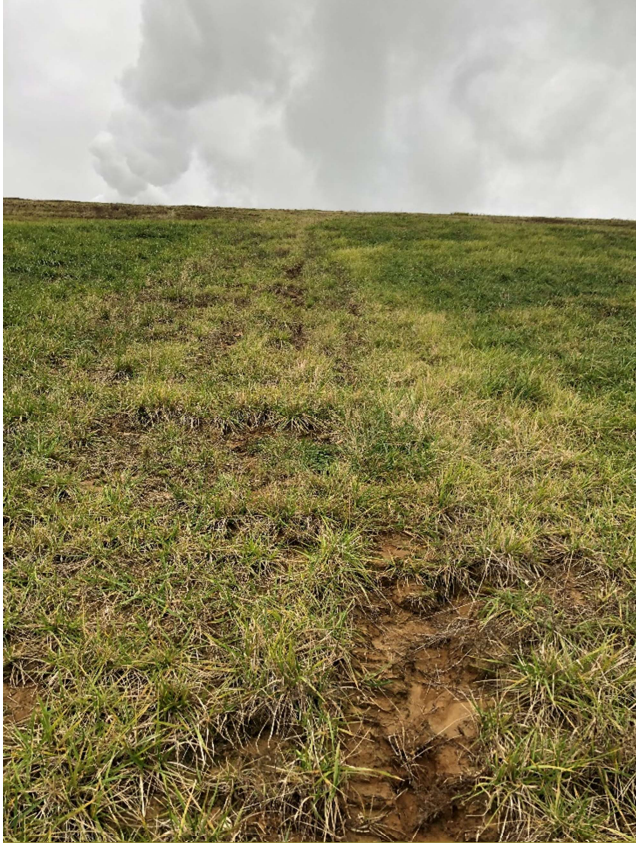
Point ID Q-19	Photo ID IMG_8323

Date October 29, 2019		
Description: Erosion rills formed along slope on eastern slope of Zone B, photo looking west.		
Point ID P-20	Photo ID IMG_8324

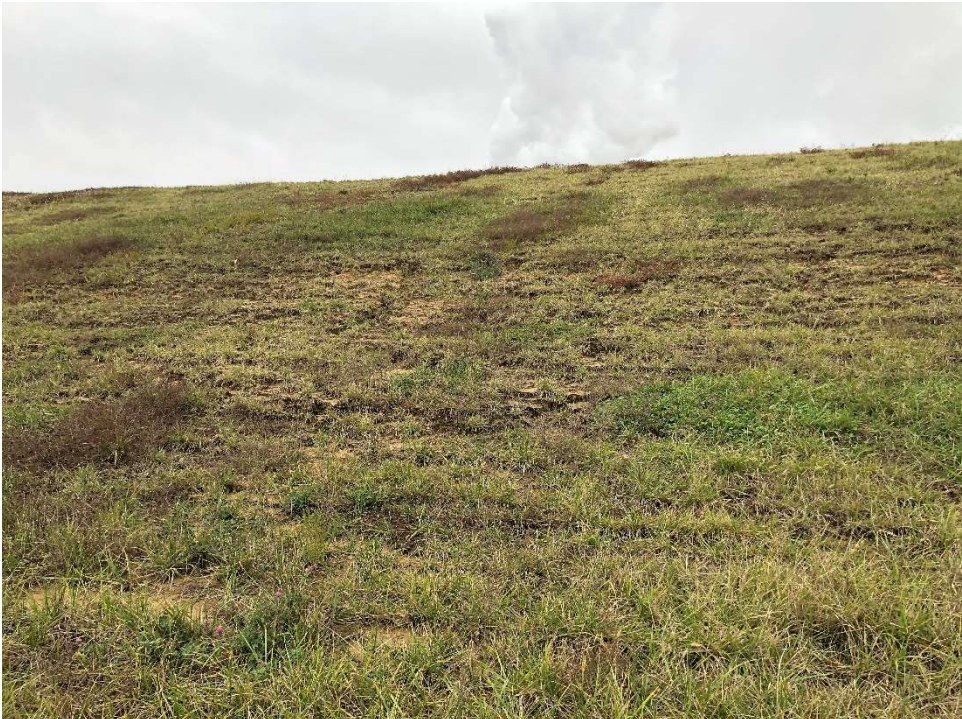
Date October 29, 2019		
Description: Erosion rills formed along slope on eastern slope of Zone B, photo looking west.

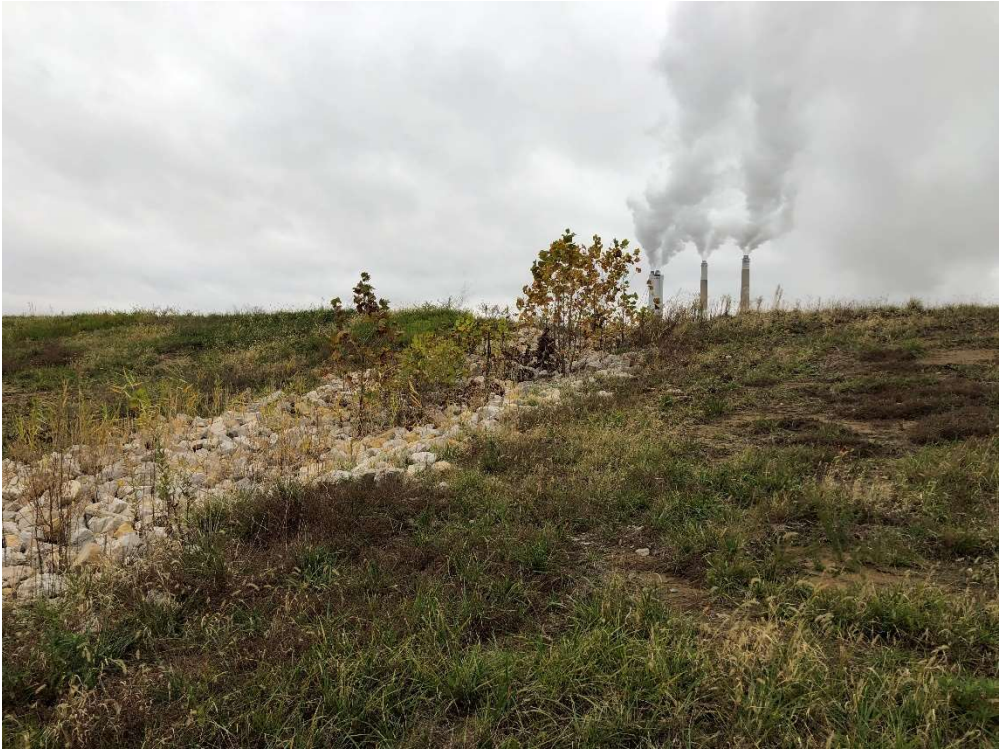
Point ID O-19	Photo ID IMG_8325

Date October 29, 2019		
Description: Saplings rooted within riprap downchute, east side slope of the landfill in Zone B, photo looking southwest.		
Point ID Q16	Photo ID IMG_8326

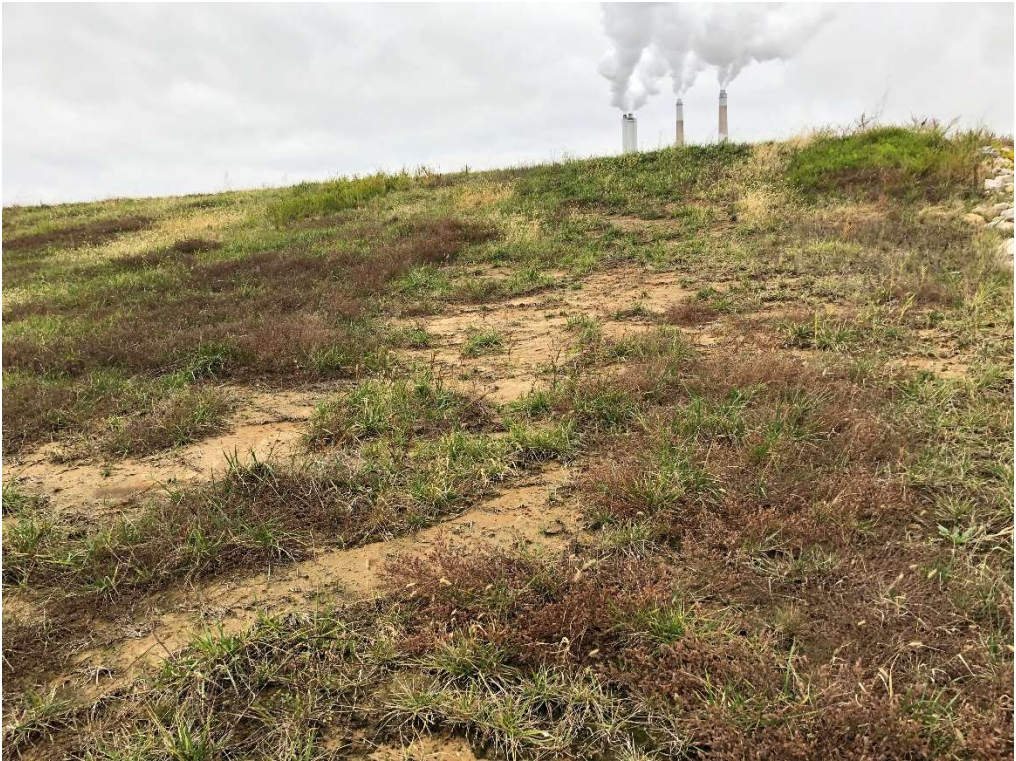
Date October 29, 2019		
Description: Sparse vegetation and erosion rills formed on eastern slope of Zone B, photo looking southwest.

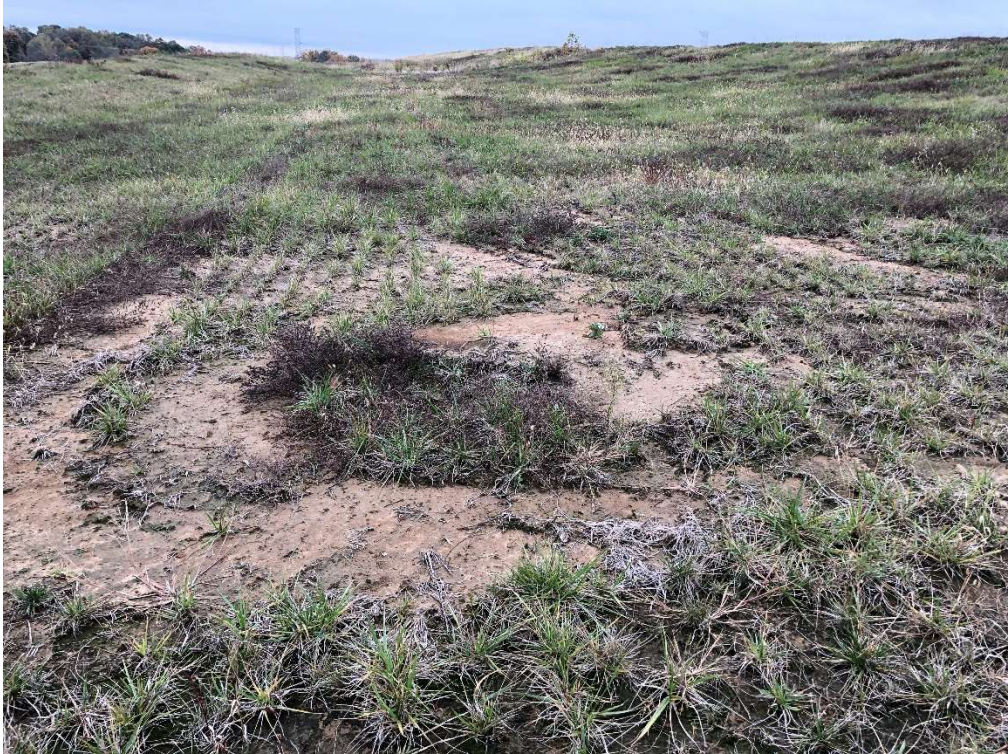
Point ID O-19	Photo ID IMG_8327

Date October 29, 2019		
Description: Sparse vegetation and erosion rills formed on eastern slope of Zone B, photo looking south.		
Point ID O-19	Photo ID IMG_8328

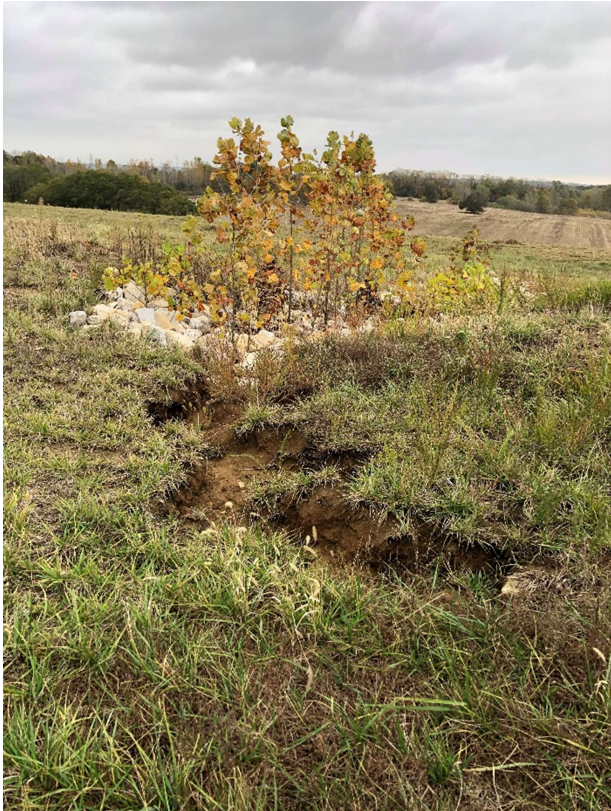
Date October 29, 2019		
Description: Erosion gully formed and saplings rooted in riprap downchute, photo looking northeast.

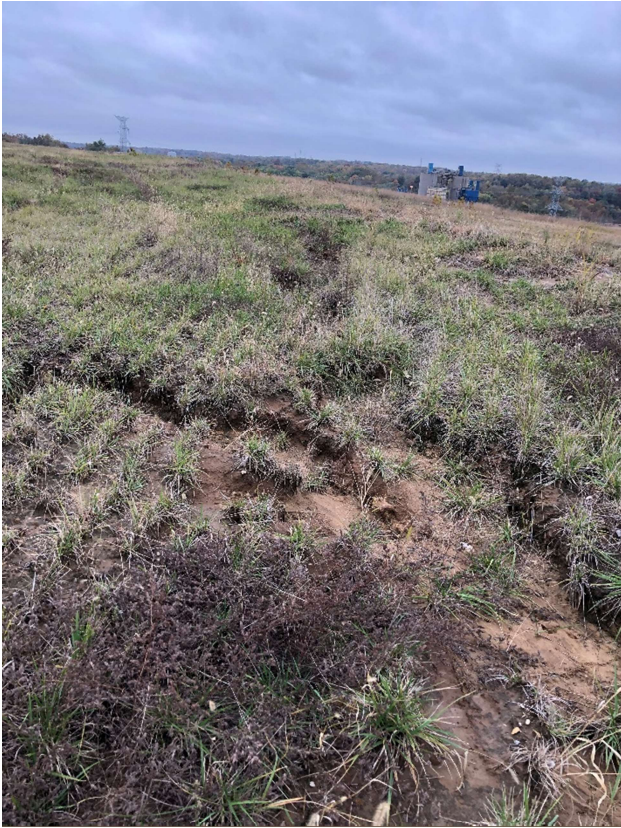
Point ID N-19	Photo ID IMG_8329

Date October 29, 2019		
Description: Erosion gullies formed on western slope of Zone B, photo looking south.		
Point ID N-19	Photo ID IMG_8330

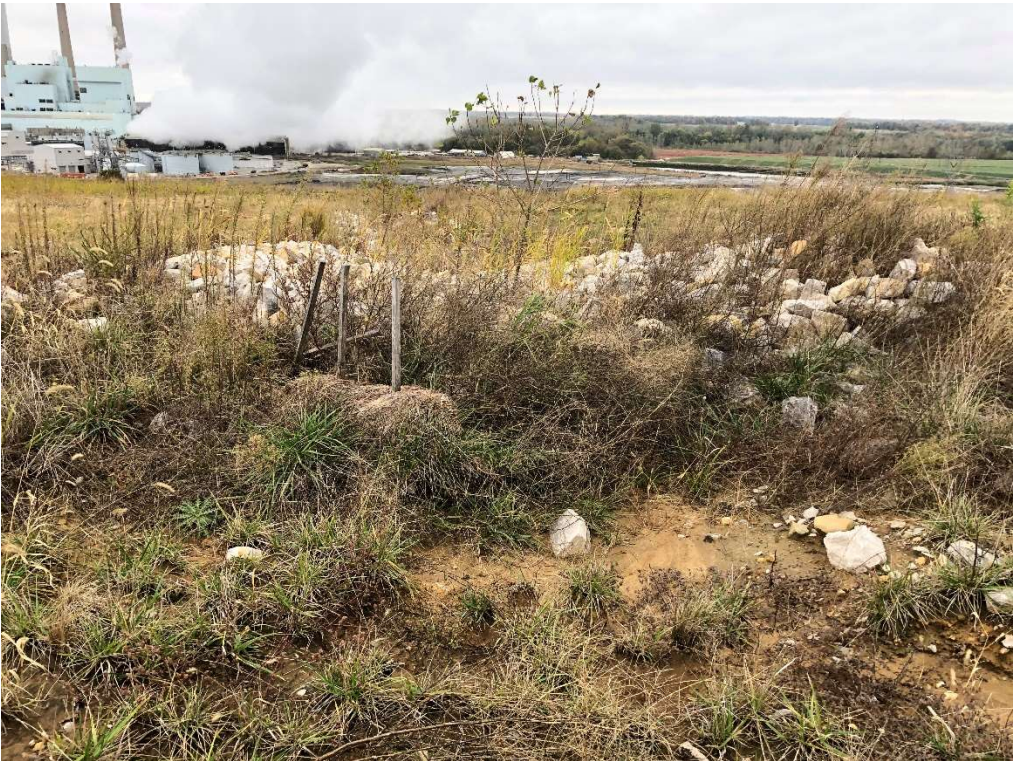
Date October 29, 2019		
Description: Erosion gully formed and saplings rooted in riprap downchute, photo looking west.

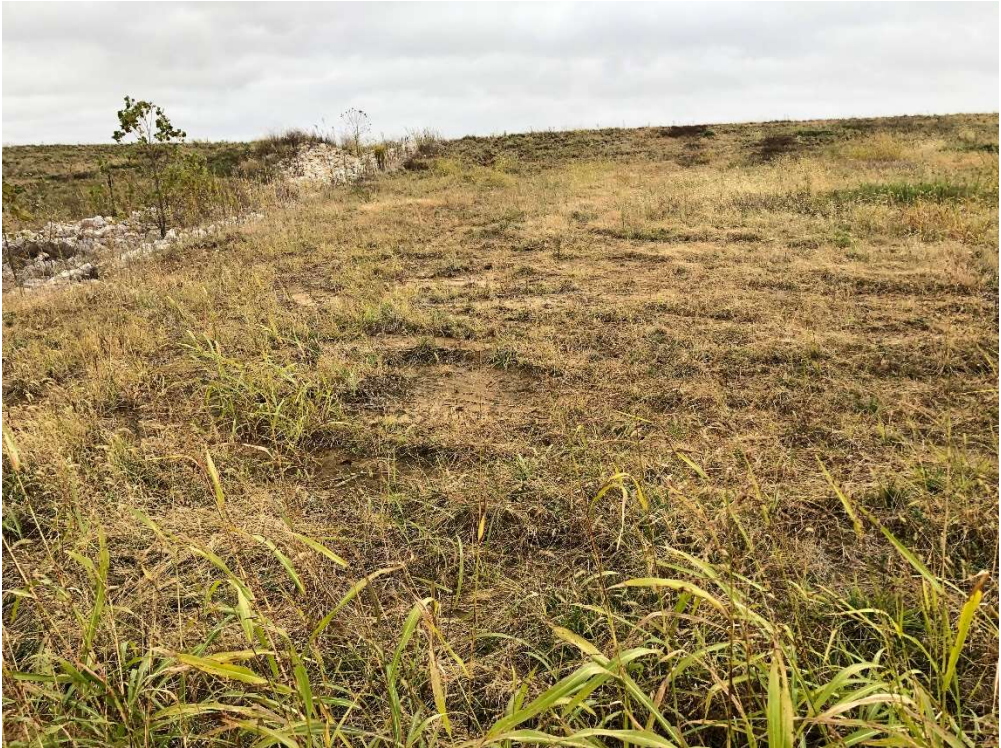
Point ID M-20	Photo ID IMG_8333

Date October 29, 2019		
Description: Sparse vegetation, saplings rooted in riprap downchute.		
Point ID M-20	Photo ID IMG_8336

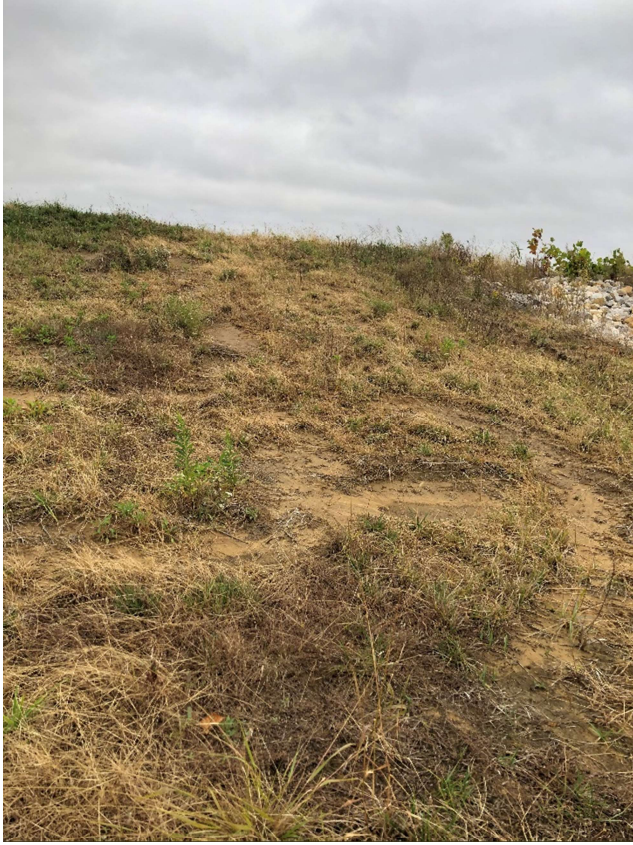
Point ID N-20	Photo ID IMG_8337

Date October 29, 2019		
Description: Sparse vegetation, saplings rooted in riprap downchute.		
Point ID N-21	Photo ID IMG_8338

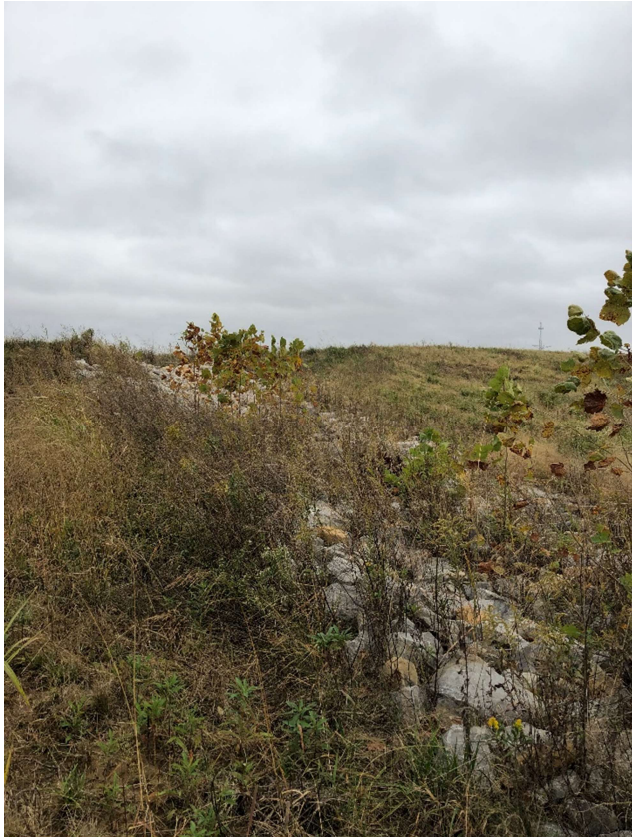
Date October 29, 2019		
Description: Vegetation growth and saplings rooted in riprap downchute, photo looking southeast.

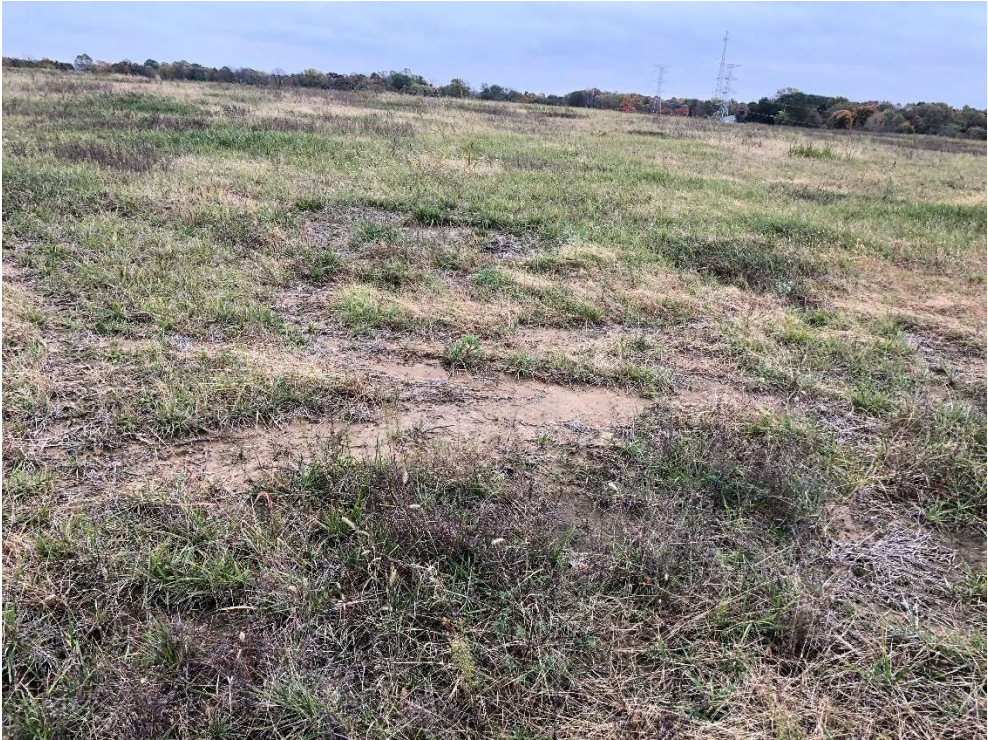
Point ID N-21	Photo ID IMG_8341

Date October 29, 2019		
Description: Sparse vegetation on southwest section of landfill, photo looking southeast.		
Point ID N-22	Photo ID IMG_8342

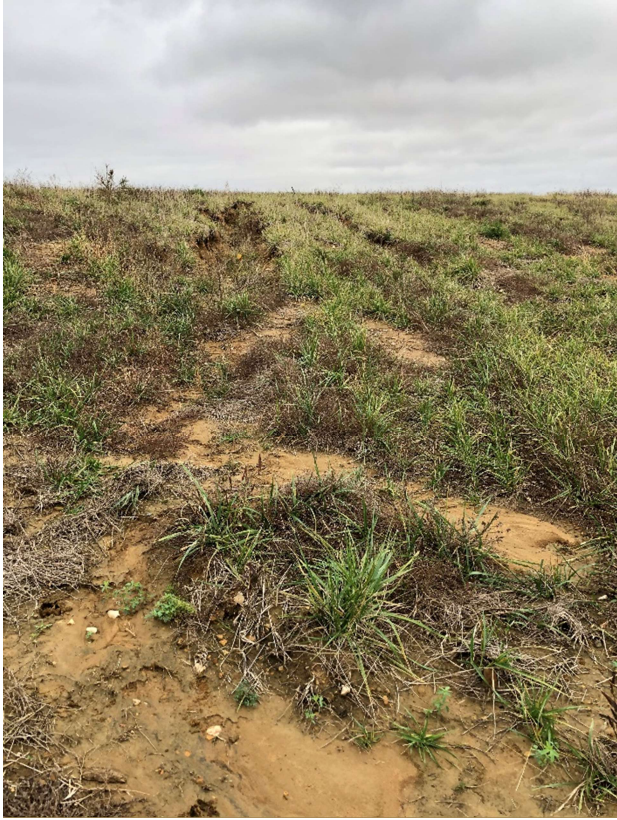
Date October 29, 2019		
Description: Erosion gullies formed, sparse vegetation cover on western slope of Zone B, photo looking west.
