**2019 VISUAL SITE INSPECTION
IPL PETERSBURG RESTRICTED WASTE TYPE III LANDFILL
SOLID WASTE FACILITY PERMIT NO. FP63-02**

IPL PETERSBURG GENERATING STATION
6925 NORTH STATE ROAD 57
PETERSBURG, INDIANA 47567

ATC PROJECT NO. 170LF00600

DECEMBER 11, 2019

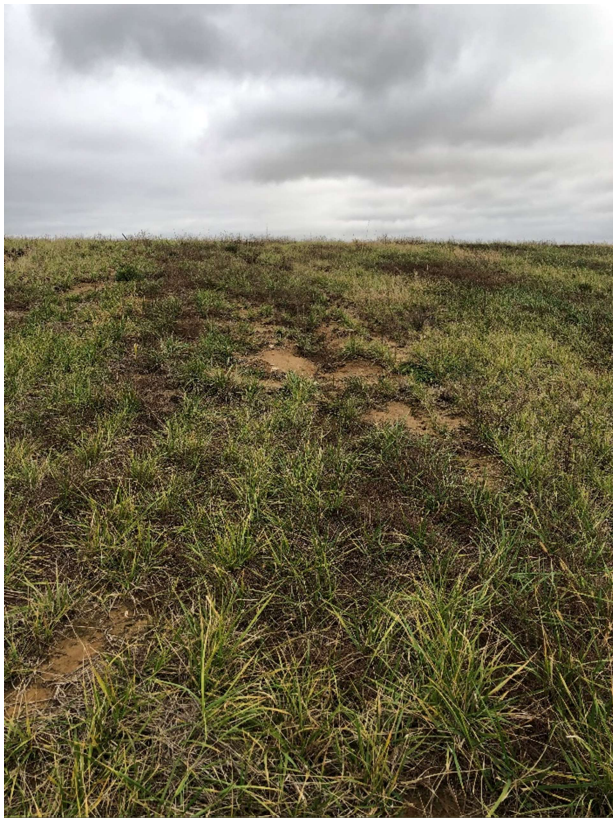
Point ID N-22	Photo ID IMG_8343

A photograph showing a narrow, sandy erosion gully cutting through a field of tall, green grass. The sky is overcast with grey clouds.
Date October 29, 2019		
Description: Erosion gully formed on western section of Zone B, photo looking northeast.		
Point ID N-23	Photo ID IMG_8344	  A photograph showing a sandy erosion gully in a field of dry, brownish grass. In the background, there is a large industrial facility with blue buildings and a tall smokestack, identified as the Petersburg Steam Station.
Date October 29, 2019		
Description: Erosion gully formed adjacent to riprap downchute, photo looking southwest.

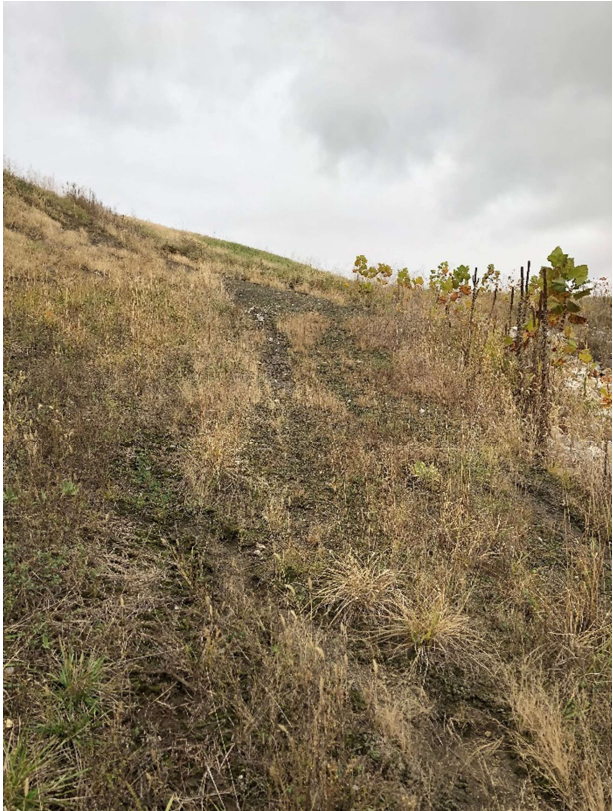
Date October 29, 2019		
Description: Erosion along south landfill slope has exposed underlying Poz-o-tec material, photo looking west.

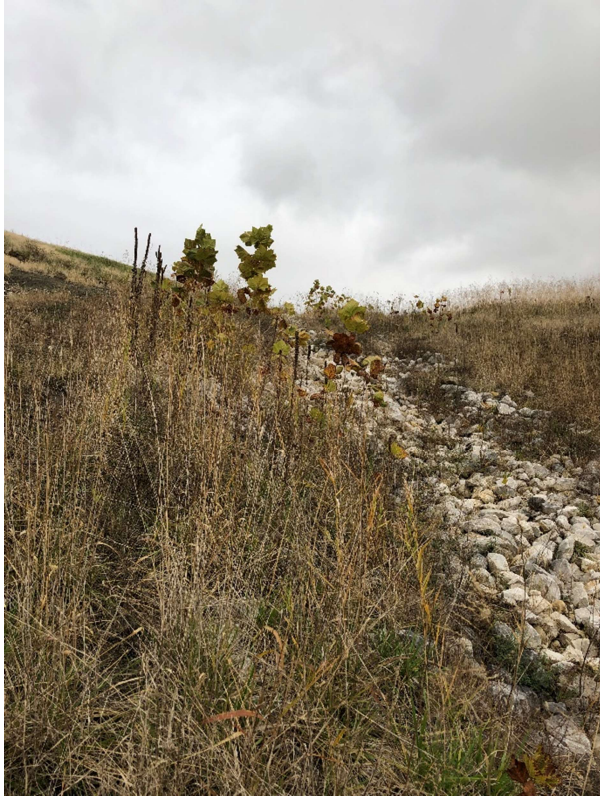
Point ID M-23	Photo ID IMG_8354

Date October 29, 2019		
Description: Saplings rooted within riprap downchute, south slope of the landfill in Zone B, photo looking north.		
Point ID M-24	Photo ID IMG_8357

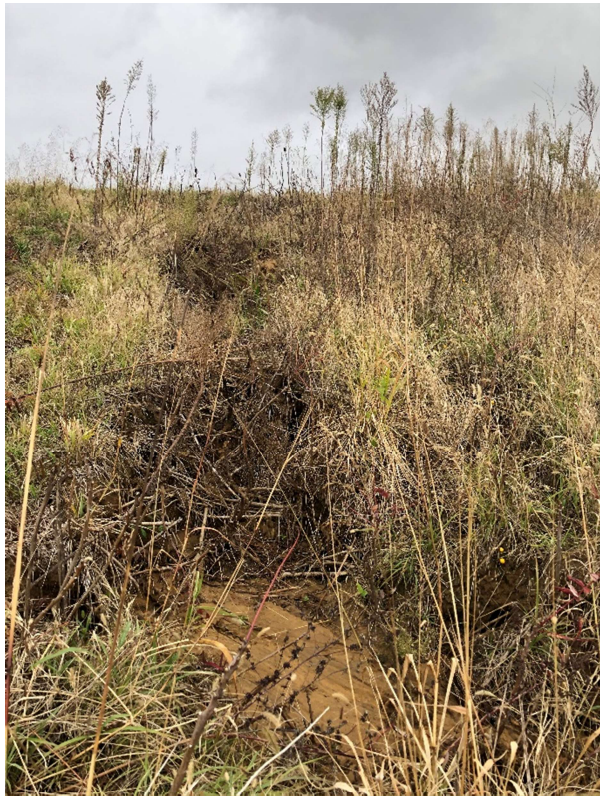
Date October 29, 2019		
Description: Erosion gully, south slope of the landfill in Zone B, photo looking north.

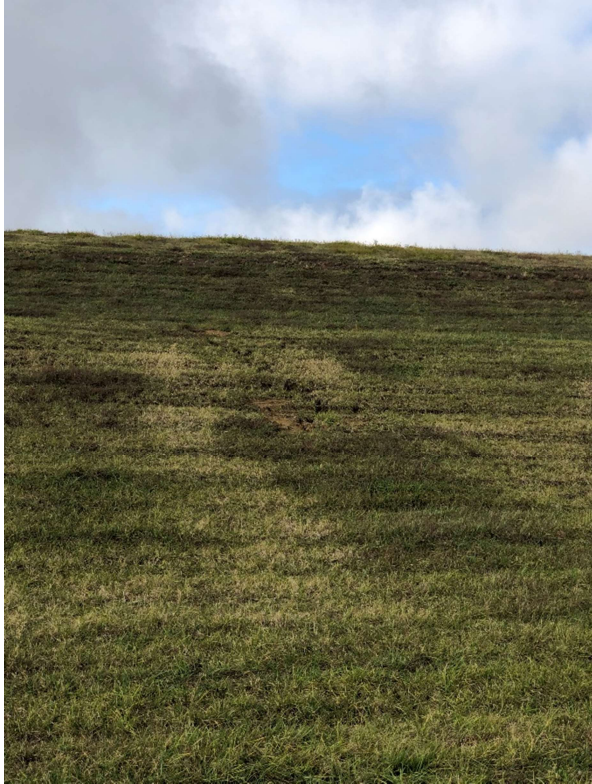
Point ID Q-18	Photo ID IMG_8362

Date October 29, 2019		
Description: Erosion rills formed on downslope of northeast section of landfill, photo looking west.		
Point ID Q-16	Photo ID IMG_8363

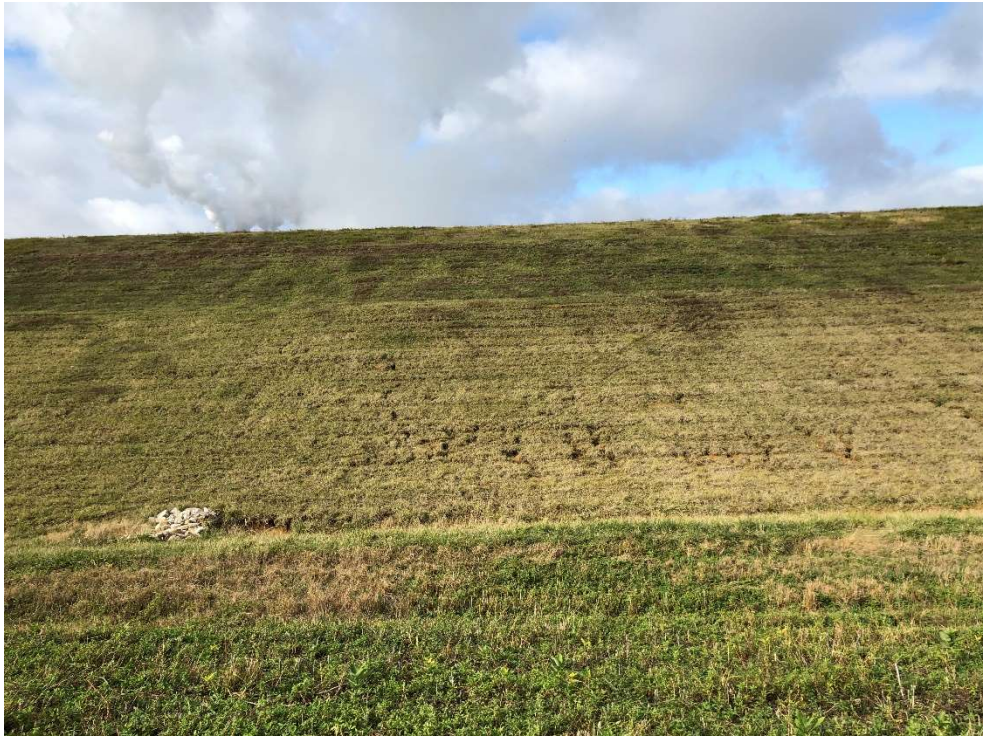
Date October 29, 2019		
Description: Erosion rills formed on downslope of northeast section of landfill, photo looking west.

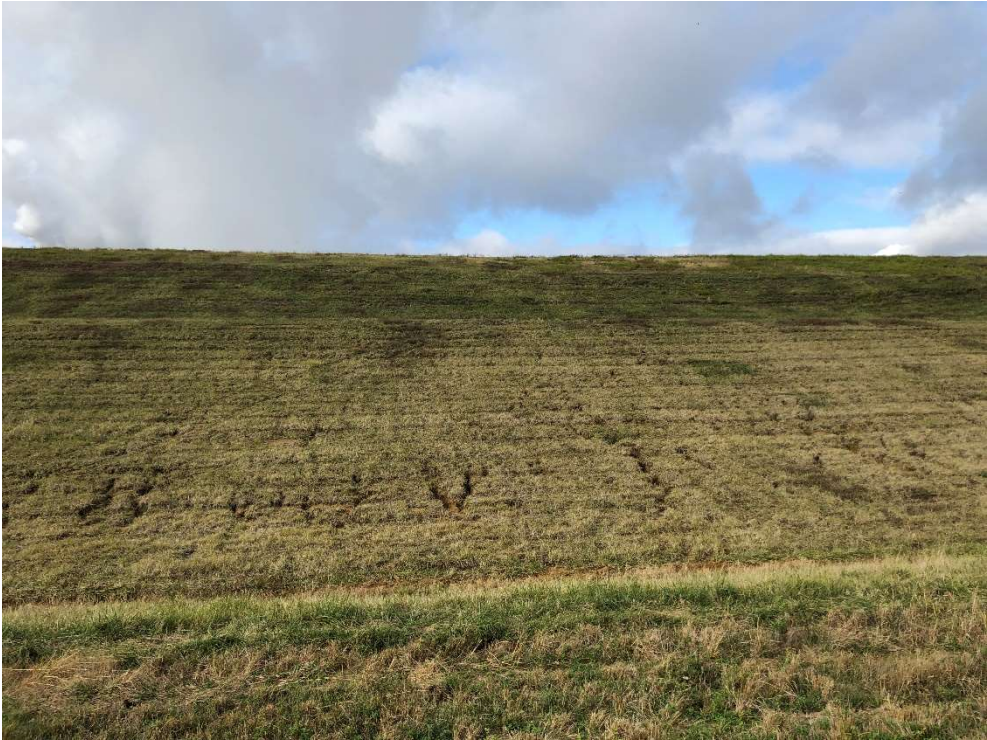
Point ID Q-16	Photo ID IMG_8364

Date October 29, 2019		
Description: Erosion rills formed on downslope of northeast section of landfill, photo looking west.		
Point ID Q-16	Photo ID IMG_8365

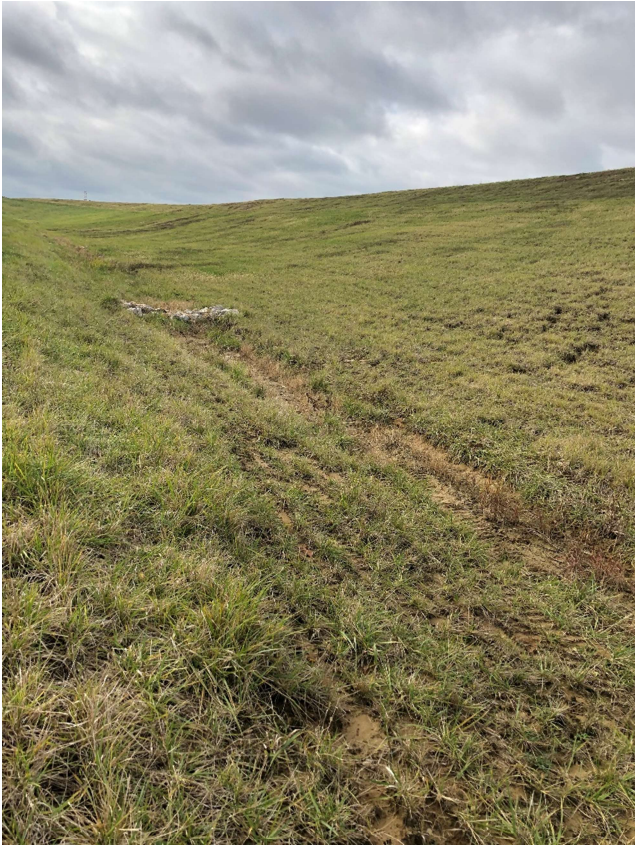
Date October 29, 2019		
Description: Erosion rills formed on bench drainage swale, east section of landfill, photo looking south.

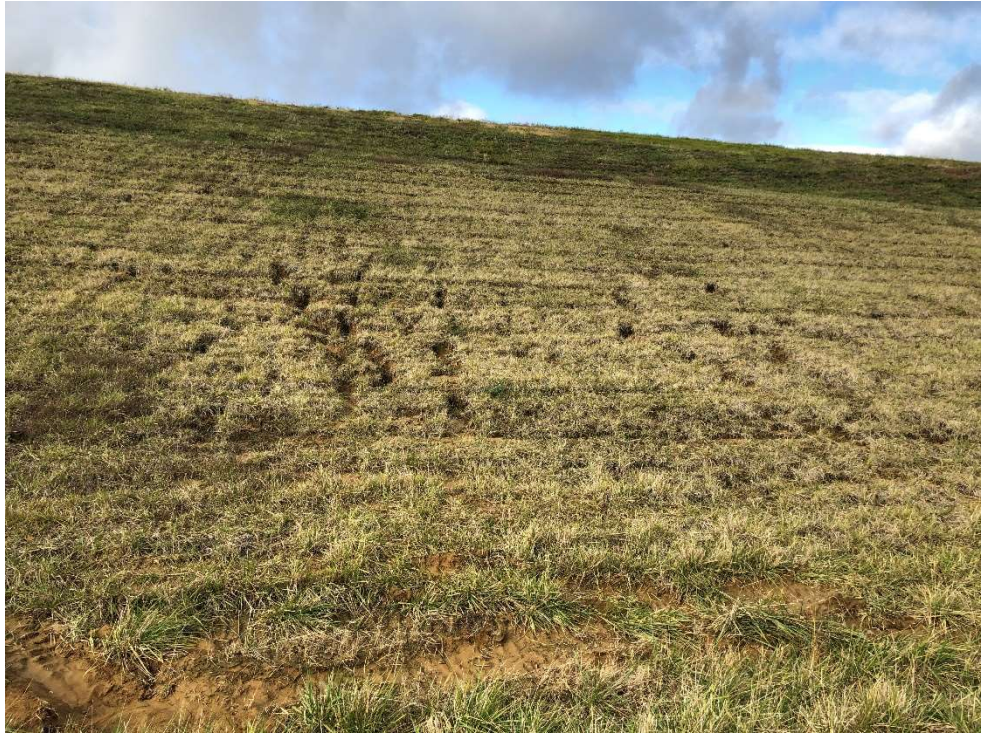
Point ID Q-16	Photo ID IMG_8366

Date October 29, 2019		
Description: Erosion rills formed on downslope of northeast section of landfill, photo looking west.		
Point ID Q-15	Photo ID IMG_8367

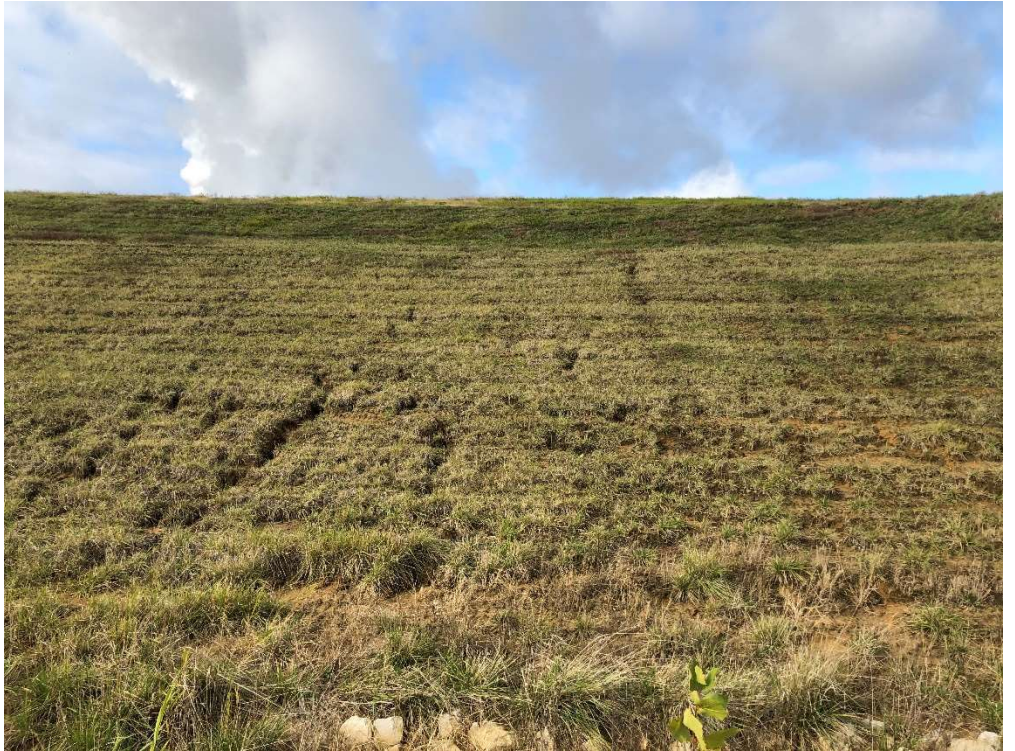
Date October 29, 2019		
Description: Erosion rills formed on downslope of northeast section of landfill, photo looking west.

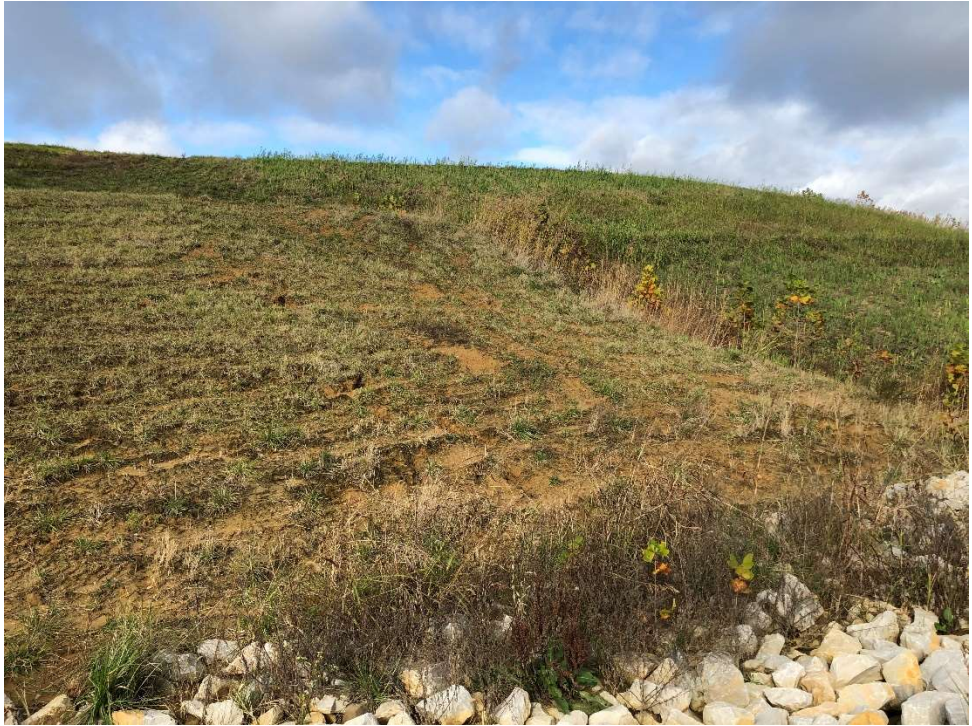
Point ID Q-15	Photo ID IMG_8368

Date October 29, 2019		
Description: Erosion rills formed on downslope of northeast section of landfill, photo looking northwest.		
Point ID P-15	Photo ID IMG_8370

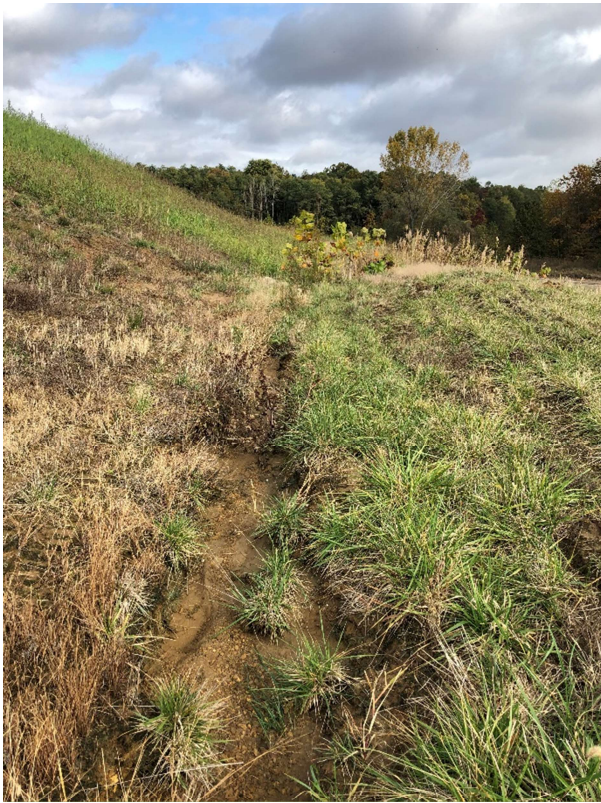
Date October 29, 2019		
Description: Erosion gullies formed along terrace swale on northeast slope of landfill, photo looking north.

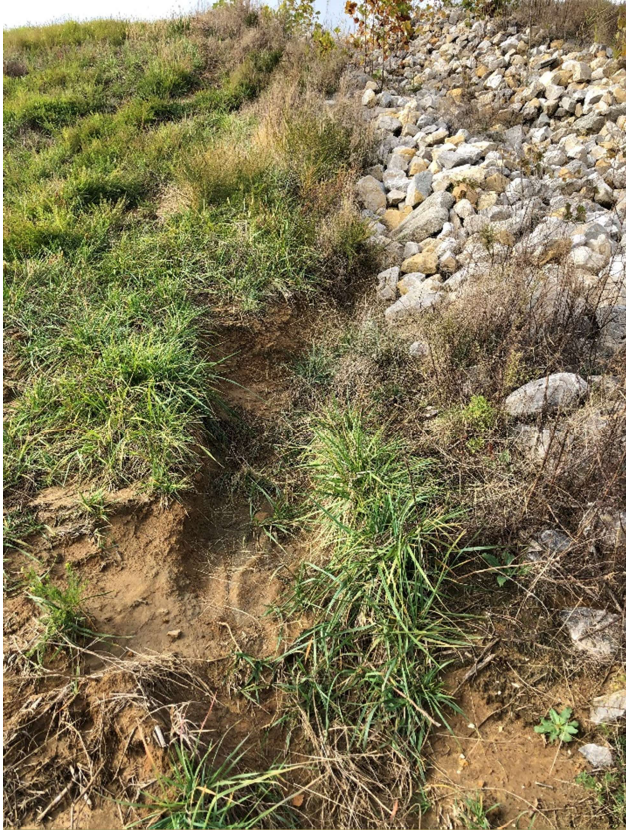
Point ID P-14	Photo ID IMG_8373

Date October 29, 2019		
Description: Erosion gully formed adjacent to riprap downchute, photo looking southwest.		
Point ID P-14	Photo ID IMG_8374

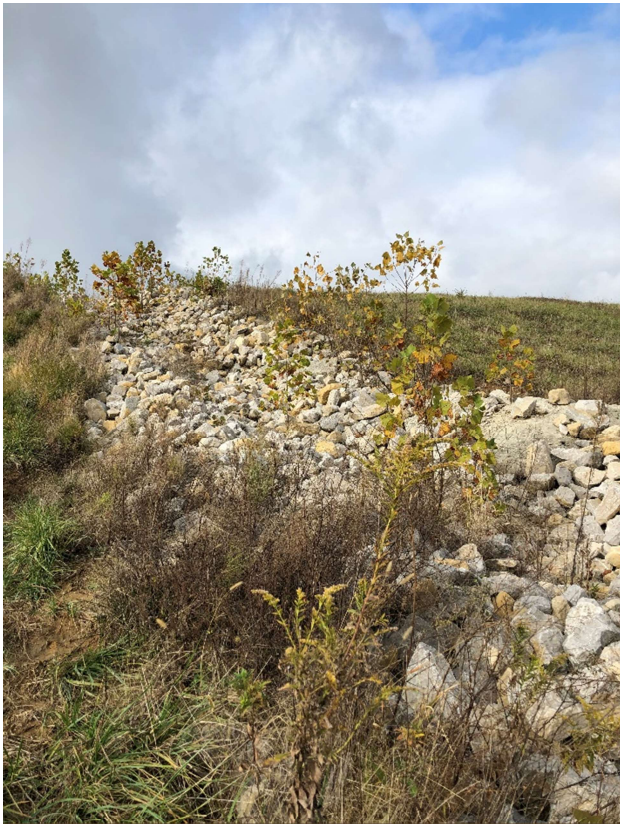
Date October 29, 2019		
Description: Saplings rooted within riprap downchute, northeast slope in Zone B, photo looking northwest.

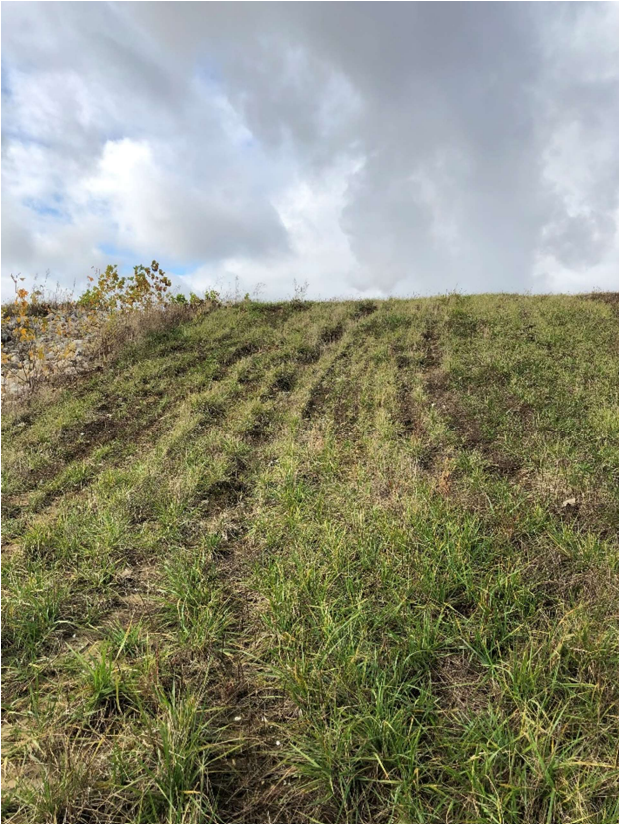
A photograph showing a wide, grassy slope of a landfill. The slope is covered with green and brown grass. There are visible erosion rills or tracks running down the slope. The background shows a line of trees under a cloudy sky.
Date October 29, 2019		
Description: Erosion rills formed in slope of the landfill, photo looking east.

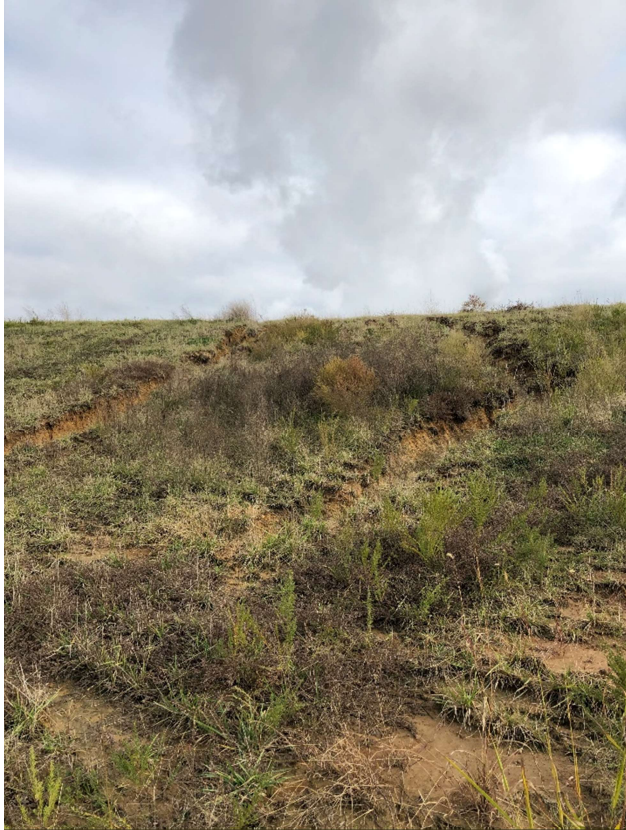
Point ID P-13	Photo ID IMG_8377

A photograph showing a steep, eroded slope of a landfill. The soil is exposed in several gullies, and the vegetation is sparse and dry. The sky is overcast with grey clouds.
Date October 29, 2019		
Description: Erosion gullies formed in slope of the landfill, photo looking west.		
Point ID P-13	Photo ID IMG_8378	  A photograph showing a wide, open area of a landfill with sparse, dry vegetation. The ground is mostly dirt and grass. The sky is overcast with grey clouds.
Date October 29, 2019		
Description: Sparse vegetation on northeast section of landfill, photo looking southeast.

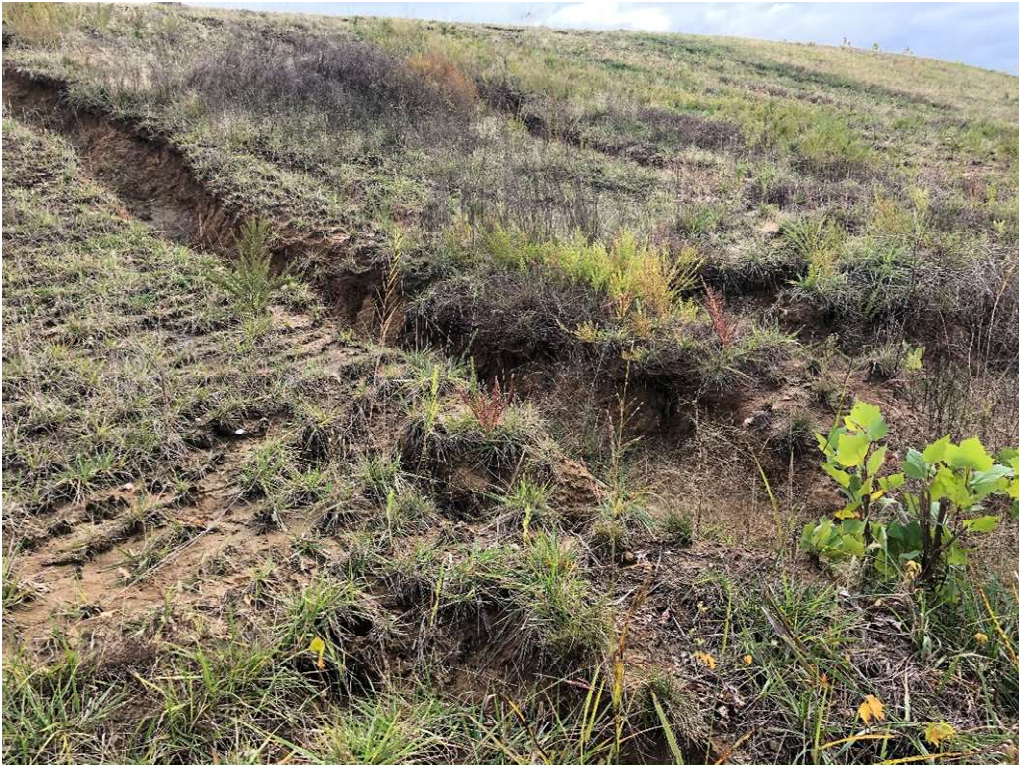
Point ID P-13	Photo ID IMG_8379

A photograph showing a steep, eroded slope of a landfill. The soil is exposed in several deep, narrow gullies. Sparse vegetation, including grasses and some small shrubs, is scattered across the slope. The sky is overcast.
Date October 29, 2019		
Description: Erosion gullies formed in slope of the landfill, photo looking west.		
Point ID N-14	Photo ID IMG_8380

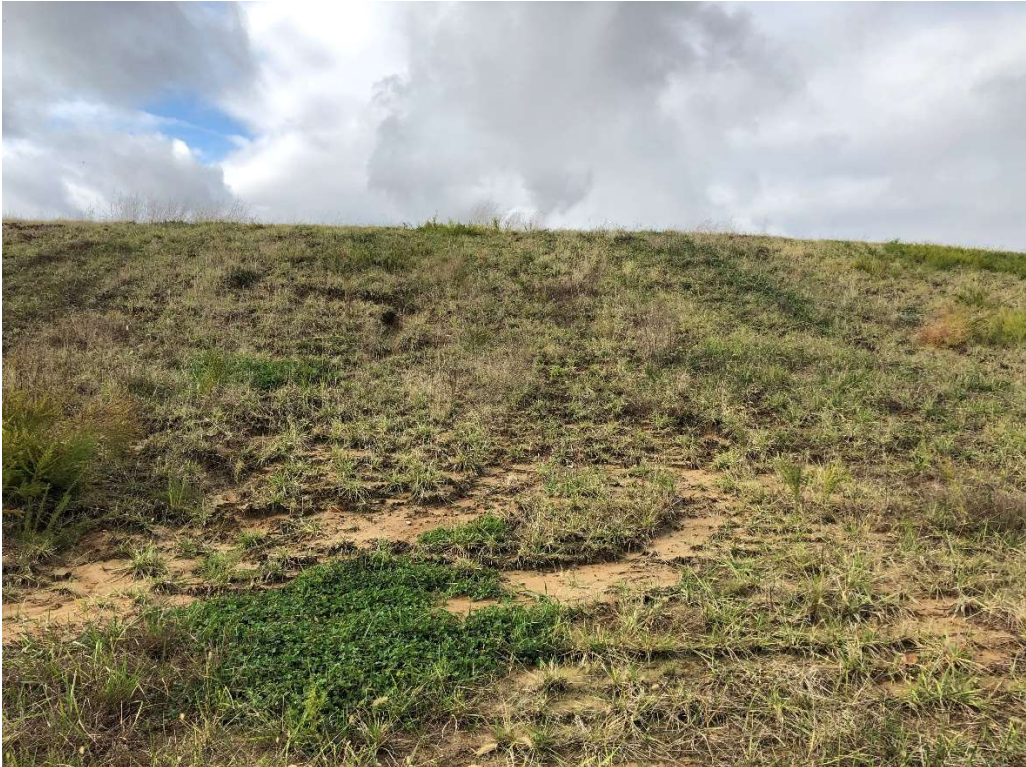
A photograph showing a wide, shallow erosion rill on a landfill slope. The soil is exposed in the center of the rill. Sparse vegetation, including grasses and some small shrubs, is scattered across the slope. The sky is overcast.
Date October 29, 2019		
Description: Erosion rills, sparse vegetation along east slope of the landfill, photo looking west.

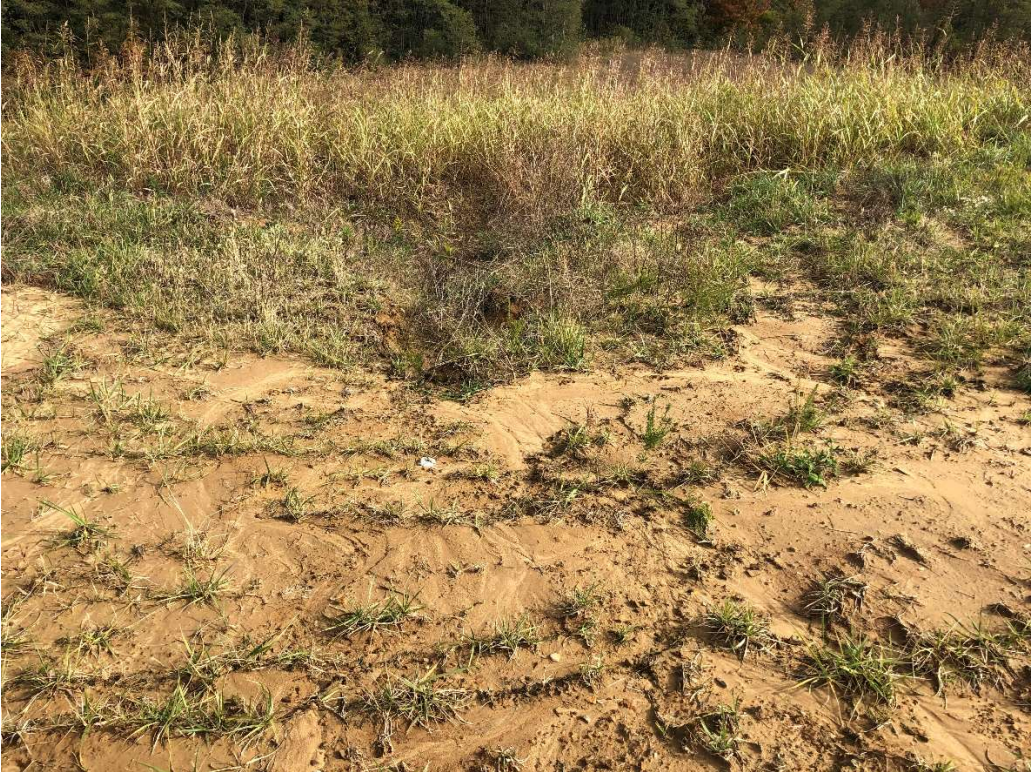
Point ID O-13	Photo ID IMG_8381

Date October 29, 2019		
Description: Sparse vegetation on northeast section of landfill, photo looking north.		
Point ID O-13	Photo ID IMG_8383

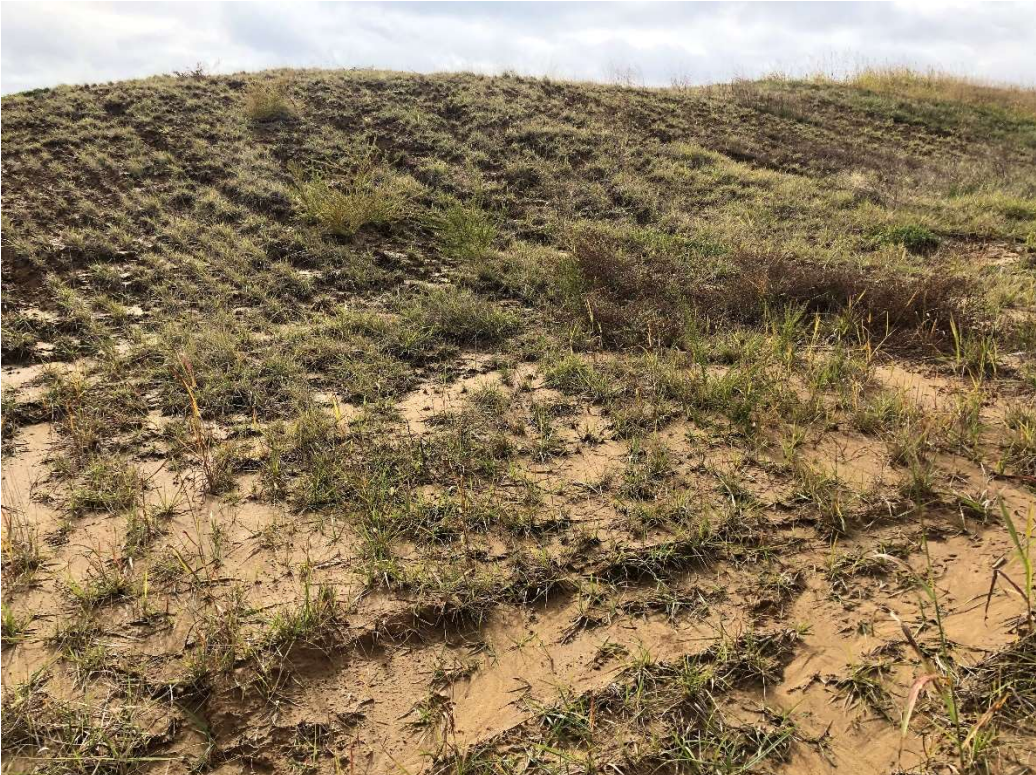
Date October 29, 2019		
Description: Sparse vegetation on northeast section of landfill, photo looking south.

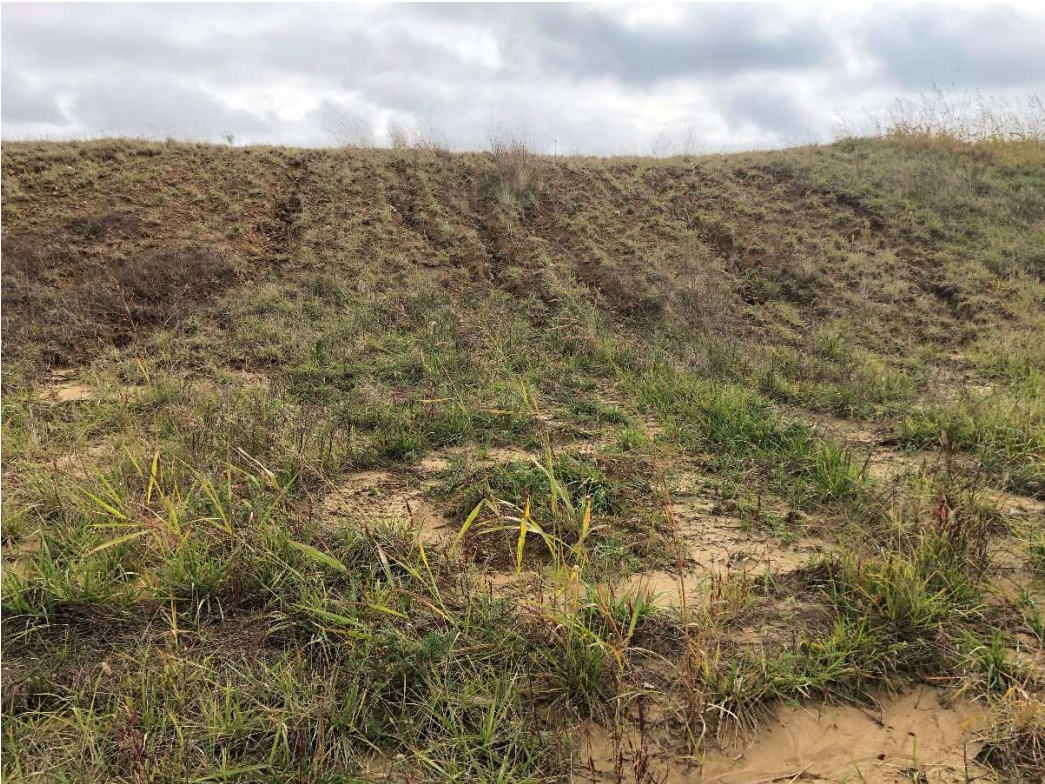
Point ID N-13	Photo ID IMG_8384

Date October 29, 2019		
Description: Erosion rills, sparse vegetation along east slope of the landfill, photo looking east.		
Point ID N-14	Photo ID IMG_8386

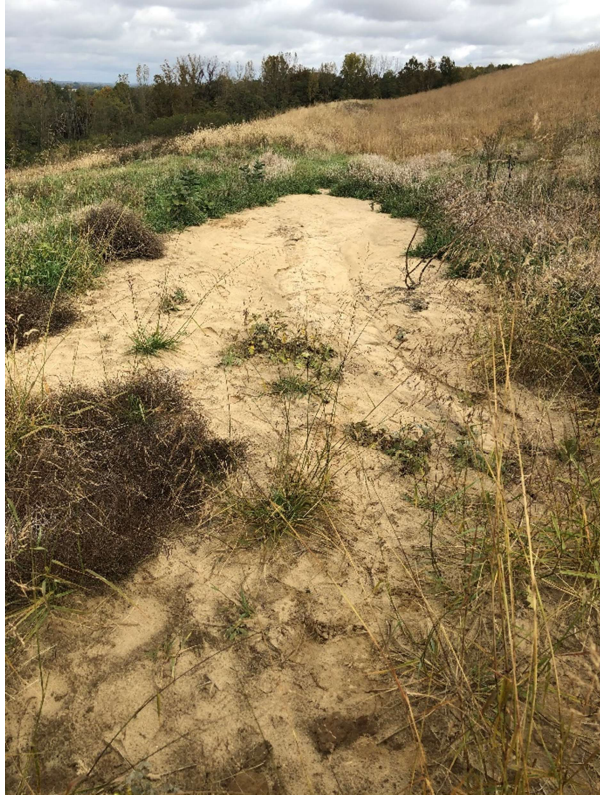
Point ID N-16	Photo ID IMG_8387

Date October 29, 2019		
Description: Sparse vegetation on northwest section of landfill, photo looking north.		
Point ID N-16	Photo ID IMG_8388	 
Date October 29, 2019		
Description: Erosion rill, northwest slope of the landfill, Zone A, photo looking west.

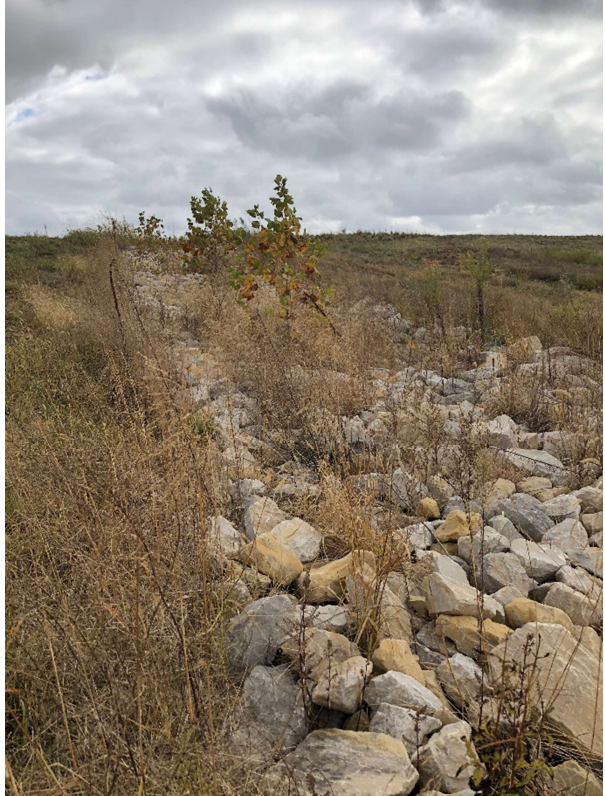
Point ID N-17	Photo ID IMG_8391

Date October 29, 2019		
Description: Saplings rooted within riprap downchute, west slope of the landfill in Zone B, photo looking east.		
Point ID N-17	Photo ID IMG_8392

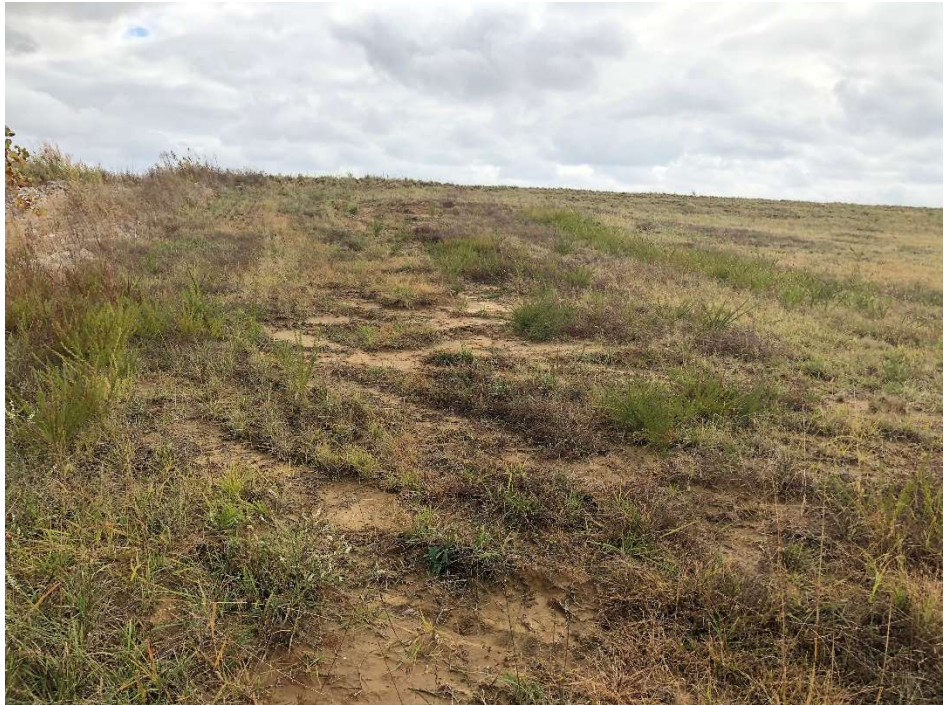
Date October 29, 2019		
Description: Sparse vegetation on west section of landfill, photo looking southeast.

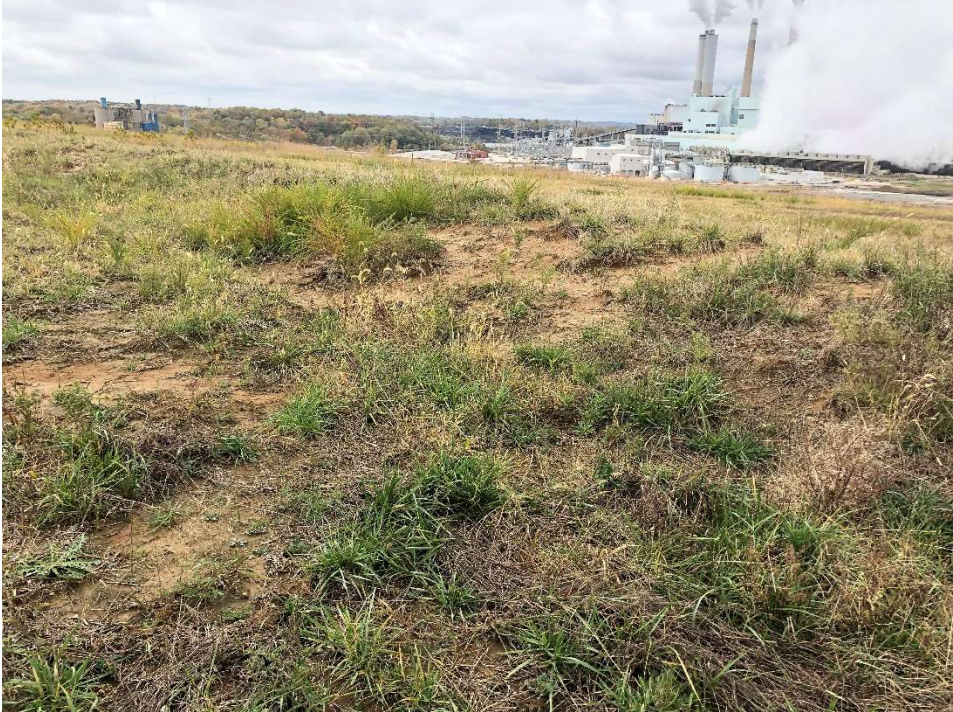
Grid ID O-17	Photo ID IMG_8393

Date October 29, 2019		
Description: Sparse vegetation on west section of landfill, photo looking southwest.		
Grid ID N-18	Photo ID IMG_8394

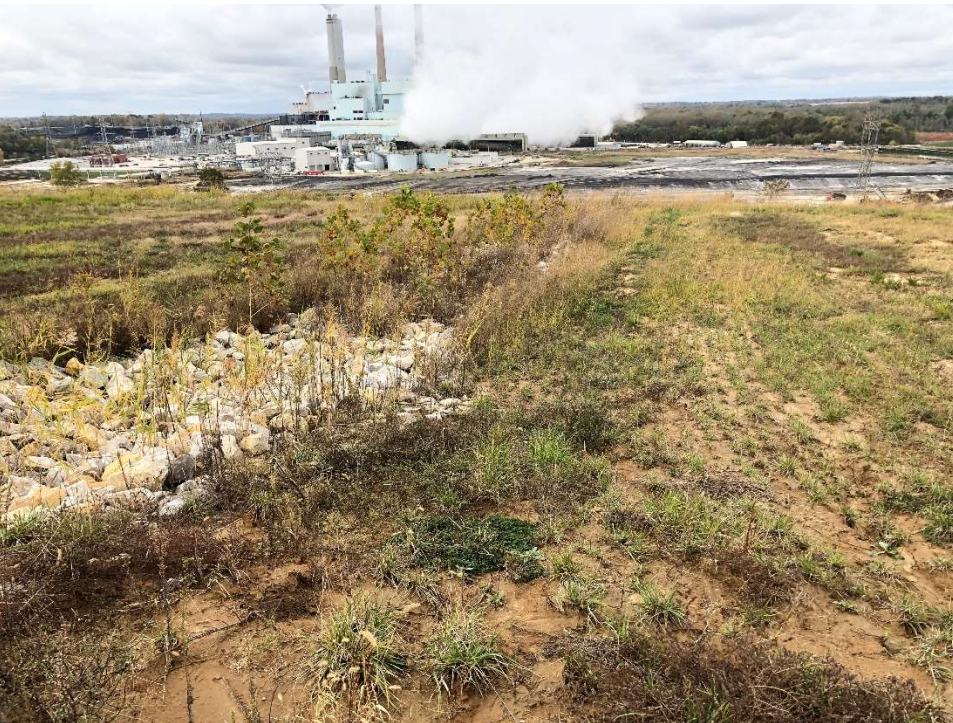
Date October 29, 2019		
Description: Saplings rooted within riprap downchute, west slope of the landfill in Zone B, photo looking southwest.

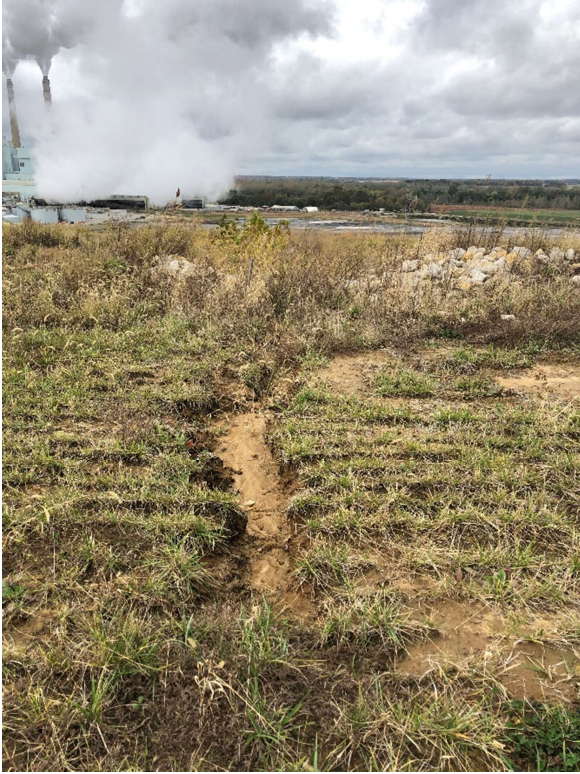
Grid ID N-18	Photo ID IMG_8395

Date October 29, 2019		
Description: Erosion gullies formed in slope of the landfill, photo looking west.

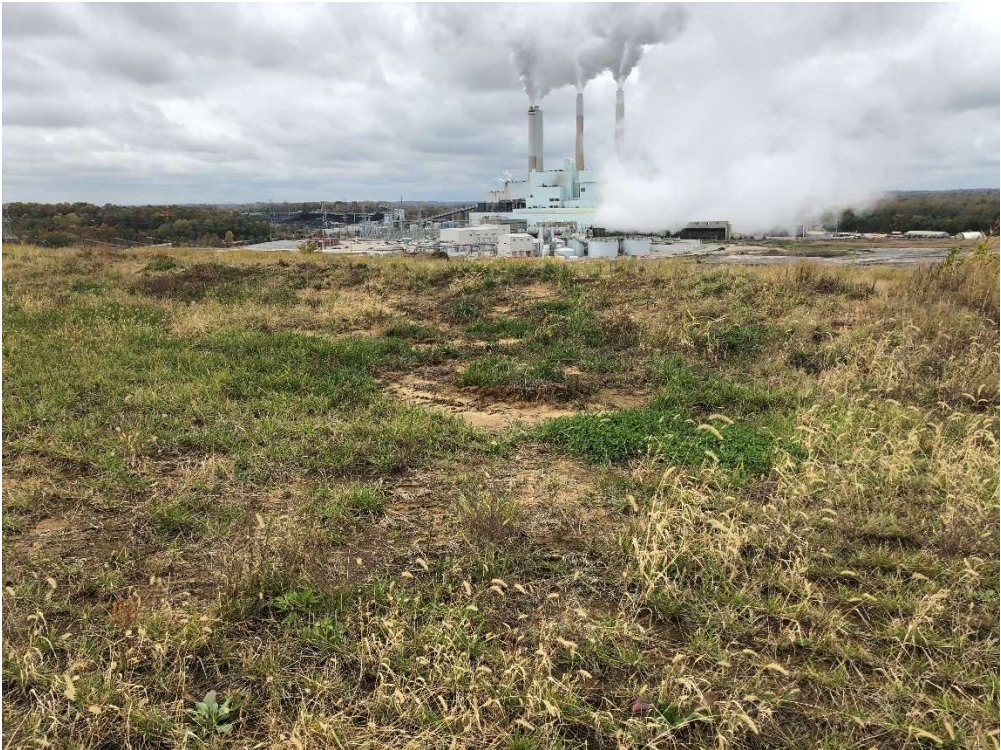
Point ID N-18	Photo ID IMG_8396	
Date October 29, 2019		
Description: Erosion gullies formed in slope of the landfill, photo looking west.

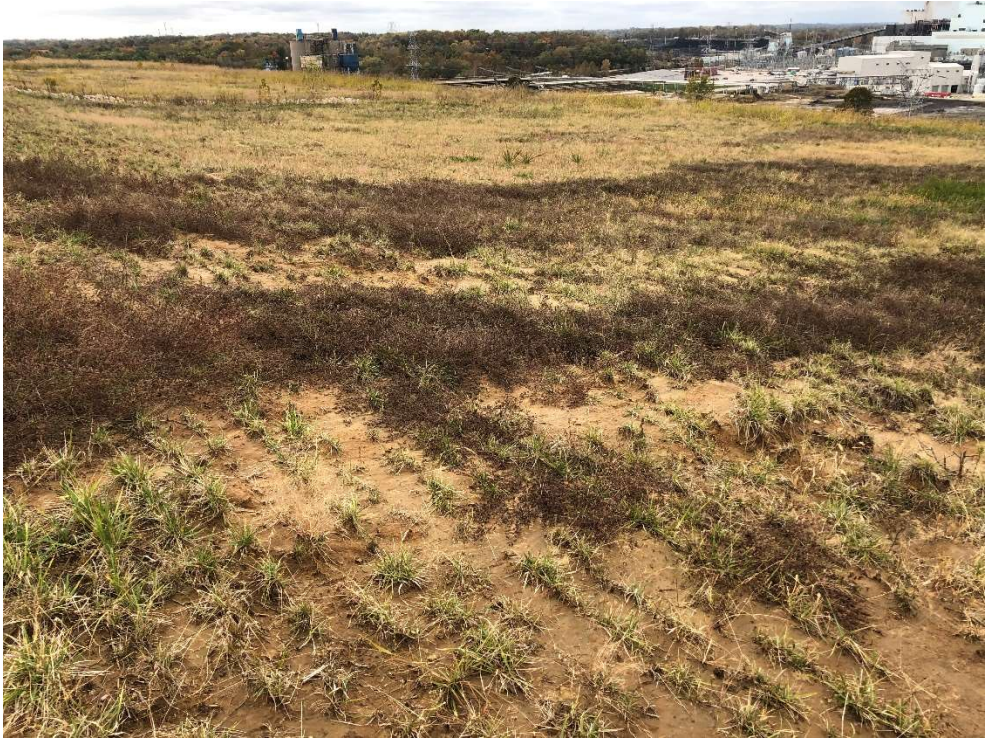
Point ID N-18	Photo ID IMG_8397

Date October 29, 2019		
Description: Sparse vegetation on east section of landfill, photo looking south.		
Point ID N-19	Photo ID IMG_8398

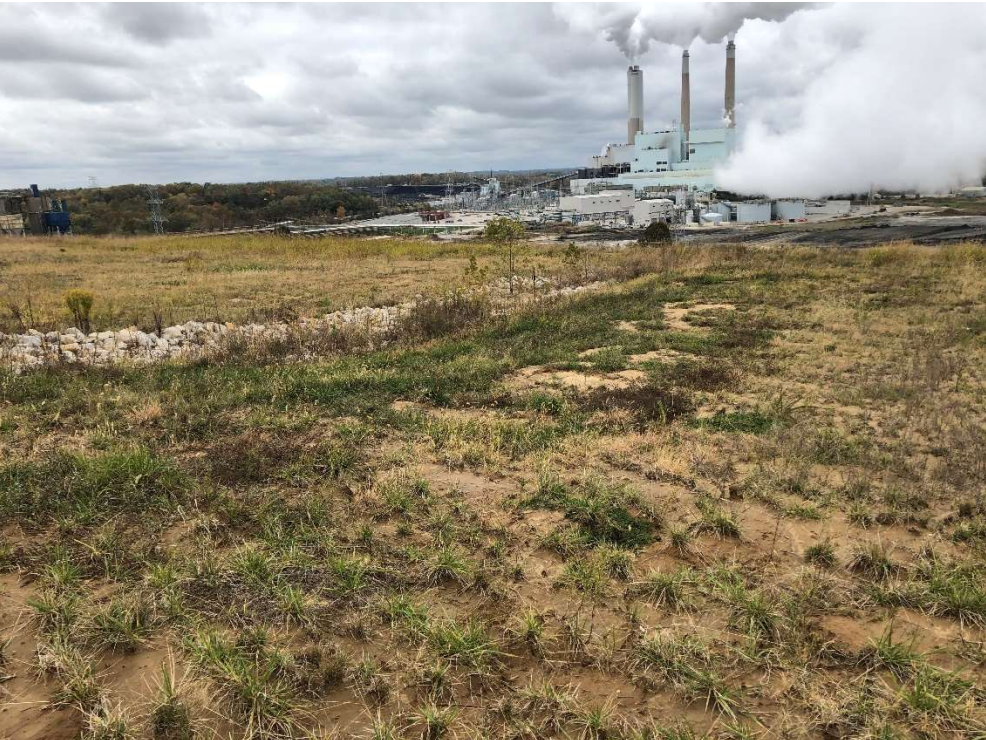
Date October 29, 2019		
Description: Saplings rooted within riprap downchute, sparse vegetation, west slope of the landfill in Zone B, photo looking southwest.

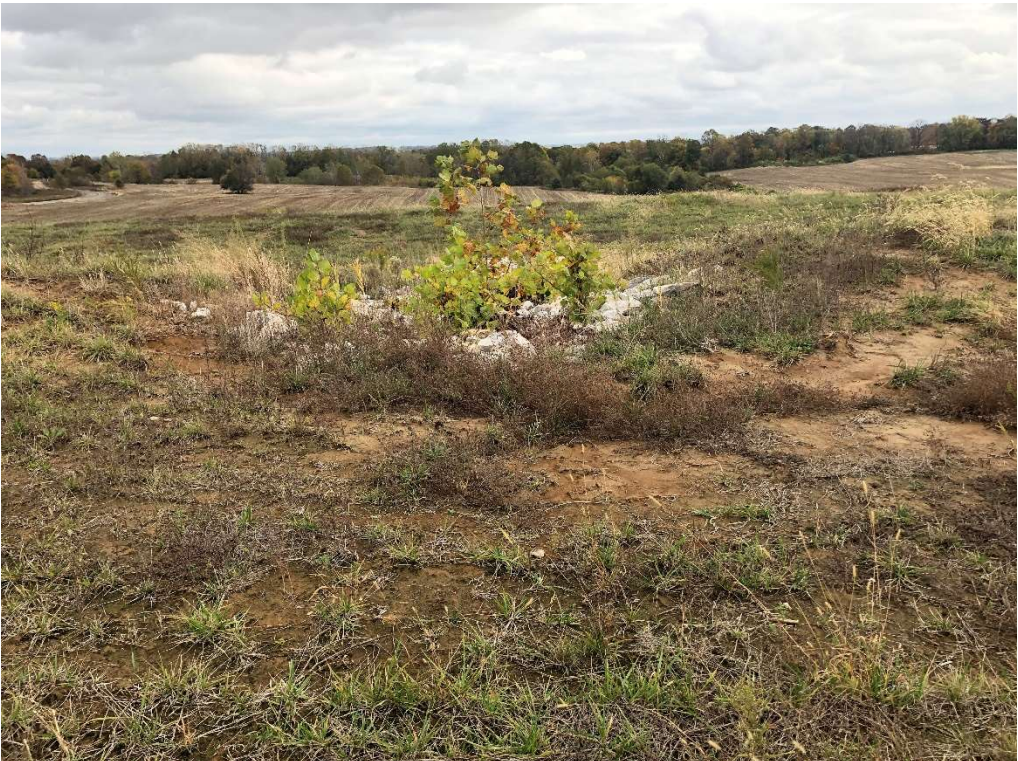
Date October 29, 2019		
Description: Sparse vegetation on east section of landfill, saplings rooted in in riprap downchute, photo looking east.

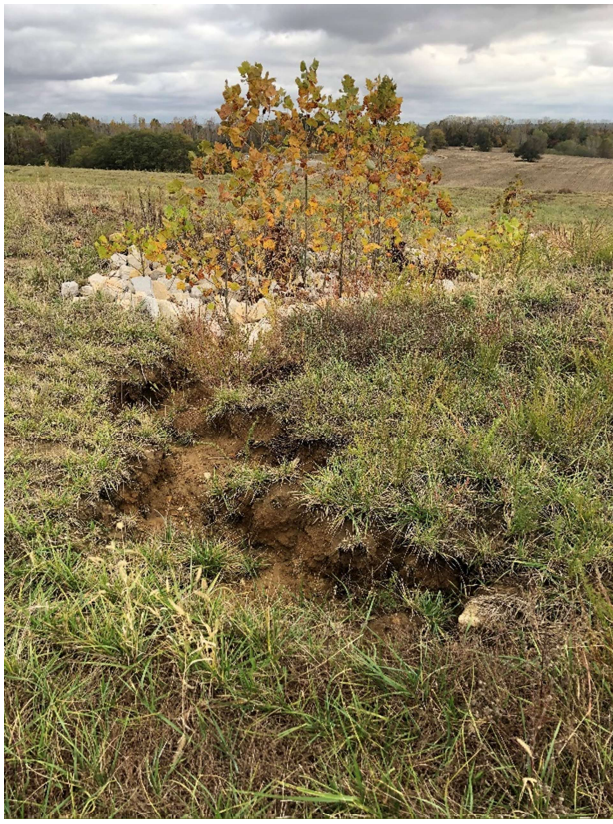
Point ID O-20	Photo ID IMG_8406

Date October 29, 2019		
Description: Erosion gullies formed in slope of the landfill, saplings rooted in riprap downchute, photo looking east.		
Point ID O-18	Photo ID IMG_8408

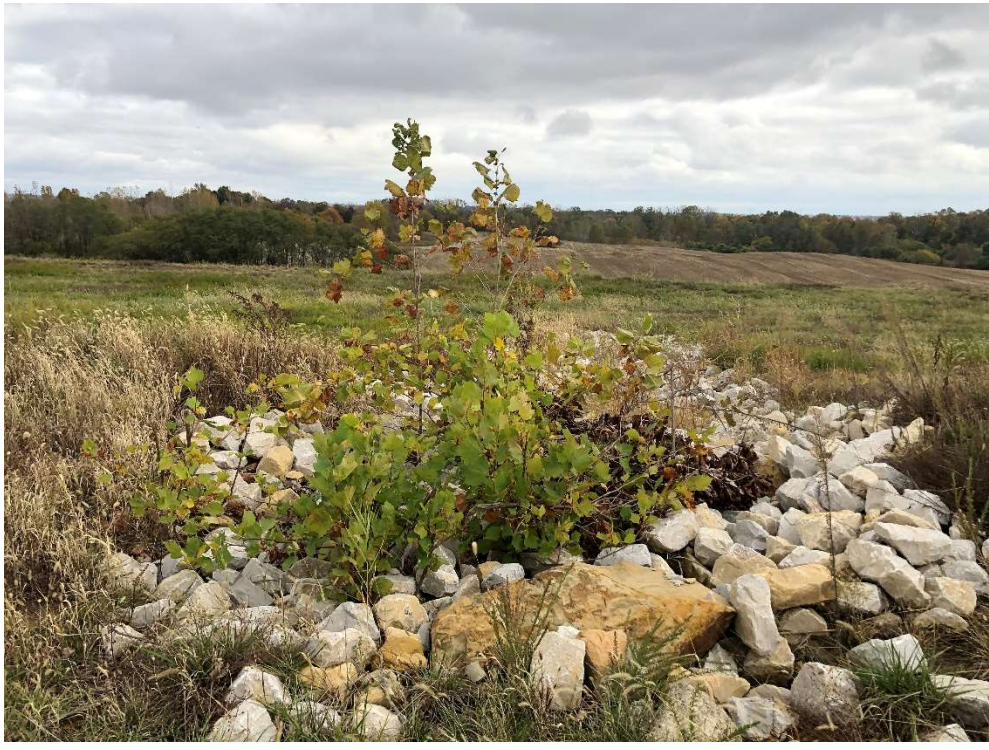
Date October 29, 2019		
Description: Saplings rooted in riprap downchute, photo looking east.
