**2019 VISUAL SITE INSPECTION
IPL PETERSBURG RESTRICTED WASTE TYPE III LANDFILL
SOLID WASTE FACILITY PERMIT NO. FP63-02**

IPL PETERSBURG GENERATING STATION
6925 NORTH STATE ROAD 57
PETERSBURG, INDIANA 47567

ATC PROJECT NO. 170LF00600

DECEMBER 11, 2019

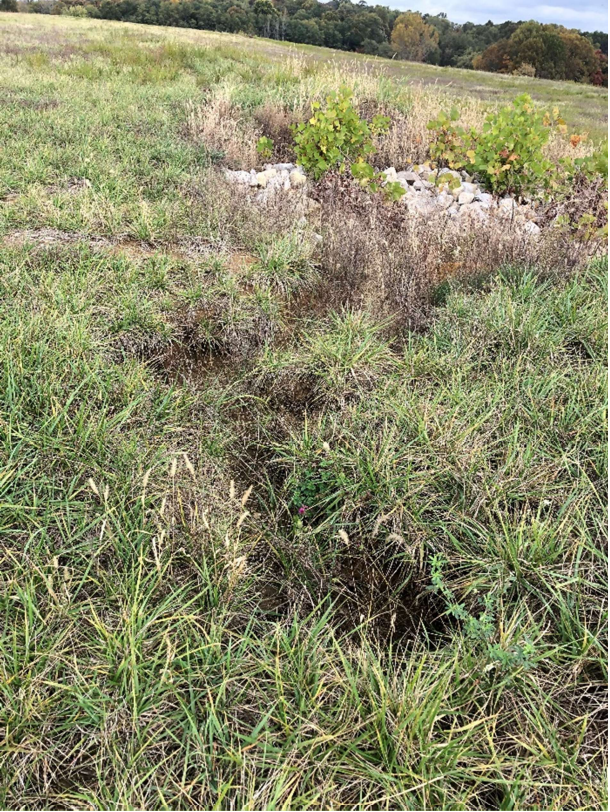
Point ID O-17	Photo ID IMG_8409

Date October 29, 2019		
Description: Erosion gullies formed in slope of the landfill, saplings rooted in riprap downchute, photo looking northeast.		
Point ID P-18	Photo ID IMG_8413

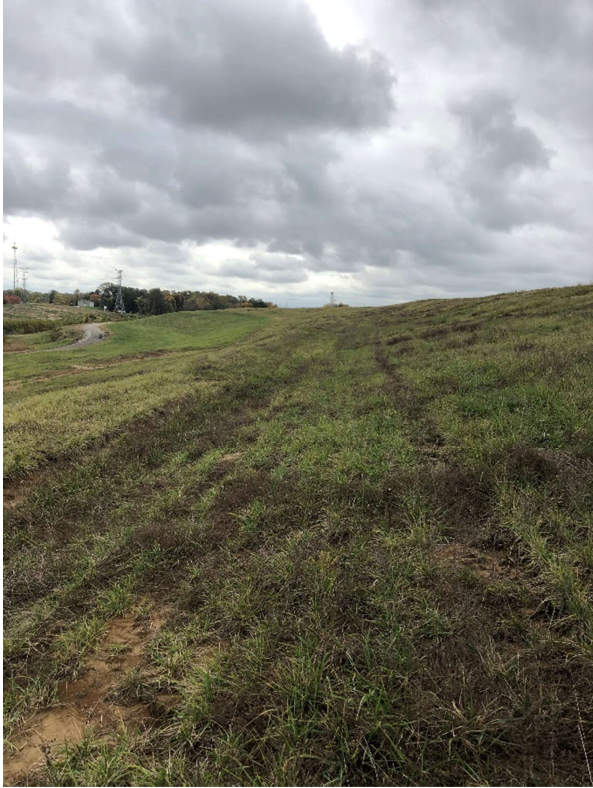
Date October 29, 2019		
Description: Erosion rills formed along terrace swale, east slope of the landfill in Zone B, photo looking south.
