**2019 VISUAL SITE INSPECTION
IPL PETERSBURG RESTRICTED WASTE TYPE III LANDFILL
SOLID WASTE FACILITY PERMIT NO. FP63-02**

IPL PETERSBURG GENERATING STATION
6925 NORTH STATE ROAD 57
PETERSBURG, INDIANA 47567

ATC PROJECT NO. 170LF00600

DECEMBER 11, 2019

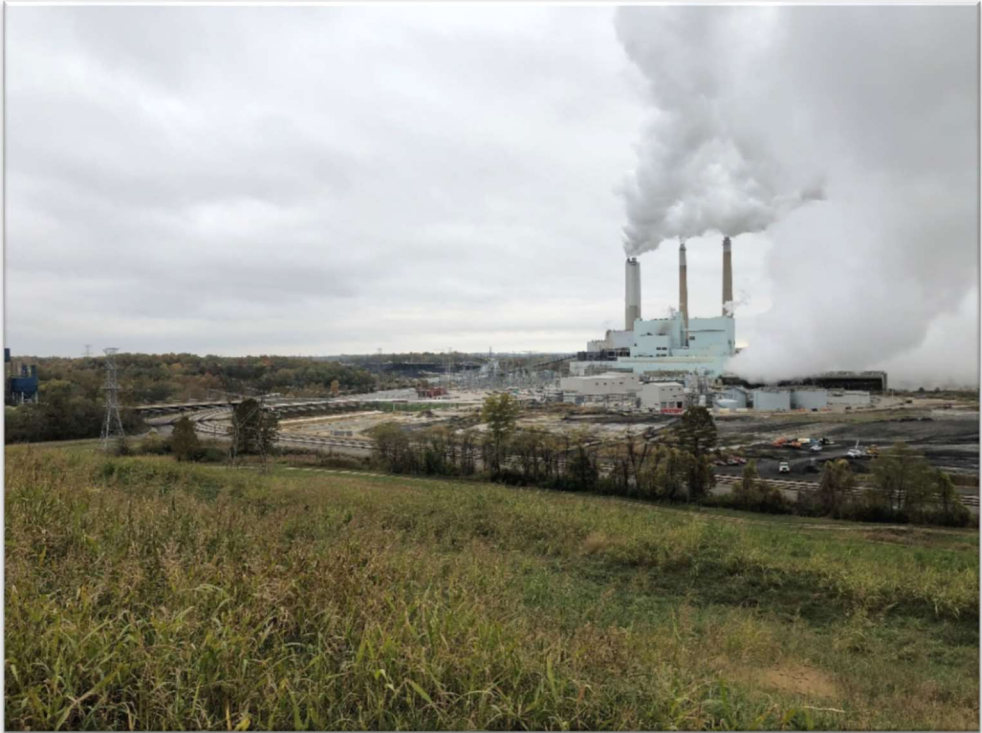
Point ID N-20	Photo ID IMG_8337

Date October 29, 2019		
Description: View of slope of landfill, Zone A, vegetation is well established, photo looking southwest.

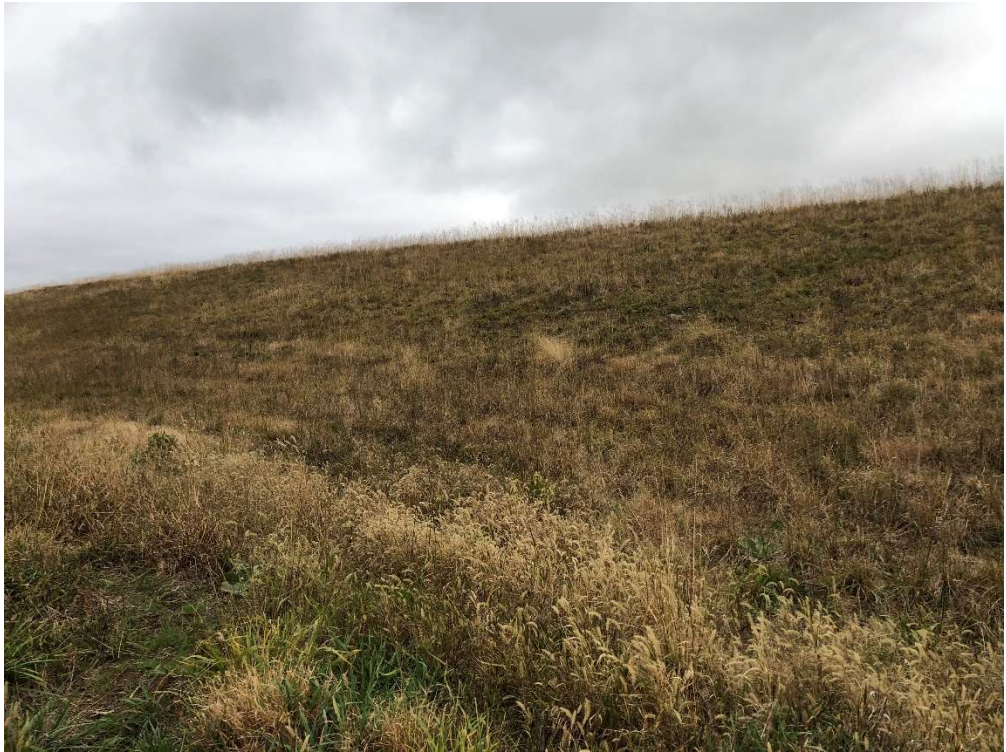
Point ID L-22	Photo ID IMG_8352

Date October 29, 2019		
Description: View of west slope of landfill, Zone A, vegetation is well established, photo looking northeast.		
Point ID M-23	Photo ID IMG_8353

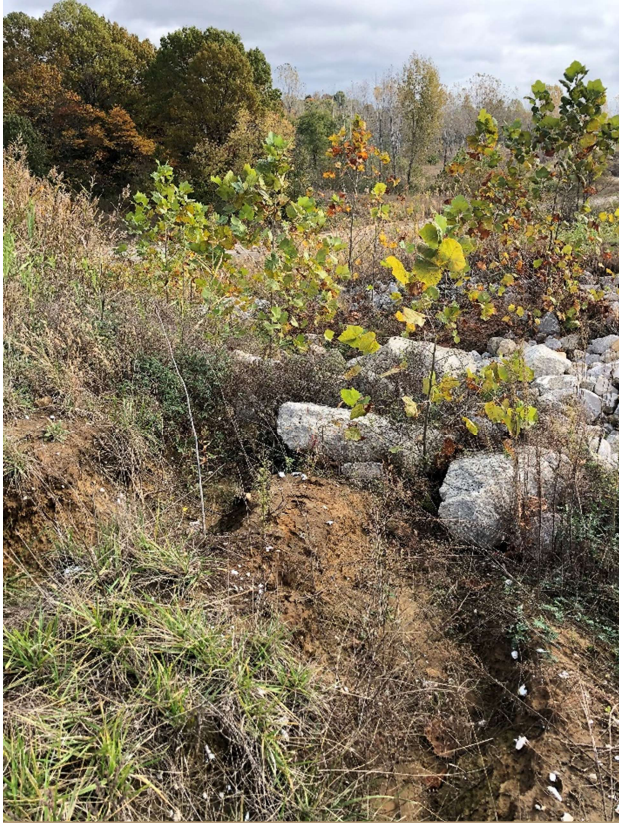
Point ID P-14	Photo ID IMG_8375

A photograph showing a steep slope with a downchute of riprap. The riprap consists of large, light-colored rocks. The slope is covered with dry grass and some green and yellow vegetation. The background shows a line of trees under a cloudy sky.
Date October 29, 2019		
Description: Erosion gullies formed, saplings rooted in riprap downchute, east slope in Zone A, photo looking east.		
Point ID P-14	Photo ID IMG_8376

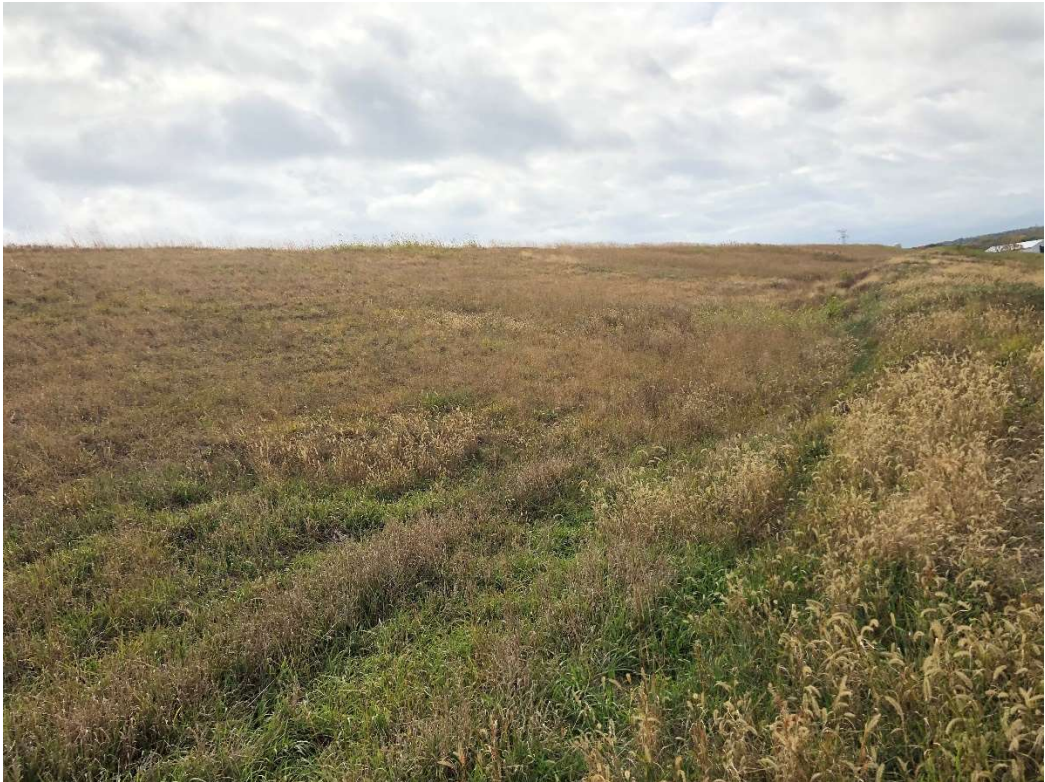
Point ID N-16	Photo ID IMG_8387

Date October 29, 2019		
Description: View of west slope of the landfill, Zone A, vegetation well established.
